## Rehabilitating Historic Storefronts

### H. Ward Jandl

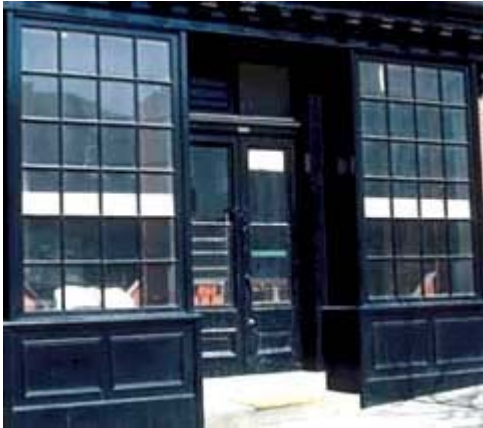
This cast iron storefront from the late 19th century has been well maintained over the years. Photo: NPS files.

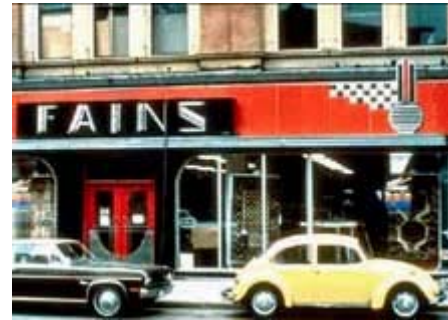
This 1930s Moderne storefront has gained significance over time and should be preserved. Photo: NPS files.

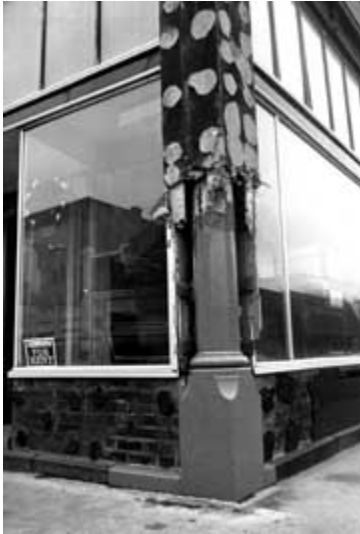
Storefronts of the 1940s, 50s, and 60s were frequently installed by attaching studs or a metal grid over an early front and applying new covering materials. Photo: Bob Dunn.

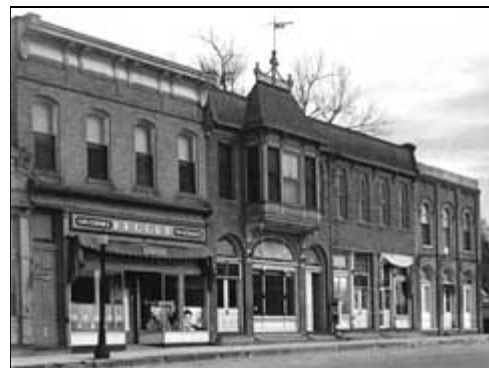
By evaluating the components of a storefront as well as their existing condition, a successful rehabilitation is more likely. Photo: HABS collection, NPS.

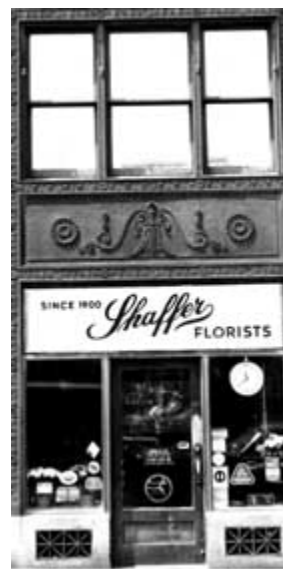
This finely detailed bronze storefront is typical of many constructed during the 1920s. The original grilles, spandrel panel

and windows are all intact. Photo: NPS files.

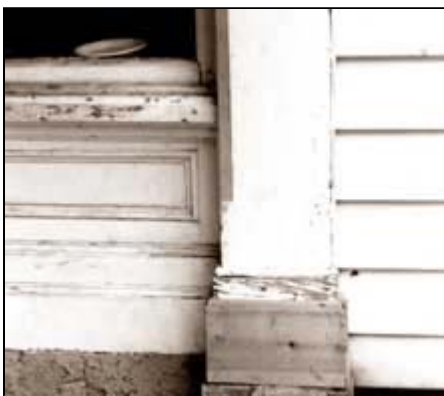
Rather than replace an entire wooden storefront, a new wooden component can be pieced-in, as seen in this column base. Photo: NPS files.

Where components of wood storefronts are so badly deteriorated that they cannot be stabilized, it is possible to replace the deteriorated parts with new pieces. These techniques all require skill and some expense, but are recommended in cases where decorative elements, such as brackets or pilasters, are involved. In some cases, missing edges can be filled and rebuilt using wood putty or epoxy compounds. When the epoxy cures, it can be sanded smooth and painted to achieve a durable and waterproof repair.

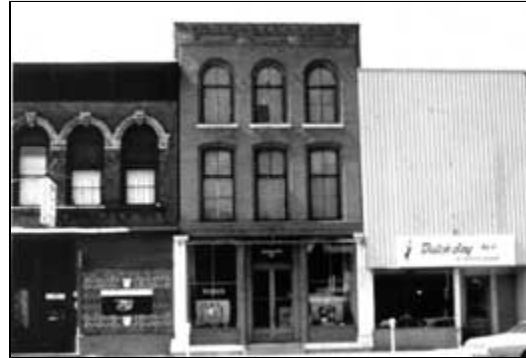
This photograph shows the impact of preserving historic storefronts. The one on the right has been totally obscured by a "modern" front added in the 1950s. Photo: NPS files.

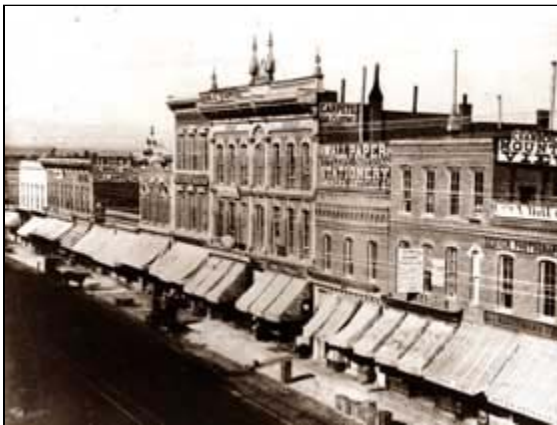
Try to locate old photographs or prints to determine what alterations have been made to the storefront and when they were undertaken. Awnings were common elements of storefronts at the turn of the century. Photo: NPS files.
