# 12 Preservation Briefs

National Park Service  
U.S. Department of the Interior

## The Preservation of Historic Pigmented Structural Glass (Vitrolite and Carrara Glass)

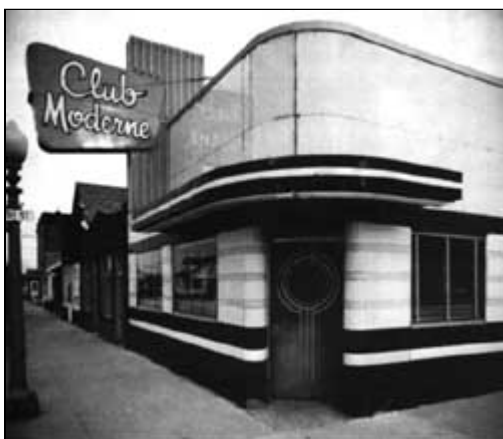
The Club Moderne, Anaconda, Montana, reflects the exceptional historic detailing associated with pigmented structural glass—polished-mirror finish, rounded corners, and horizontal polychrome bands. Photo: Jet Lowe, HAER collection, NPS.

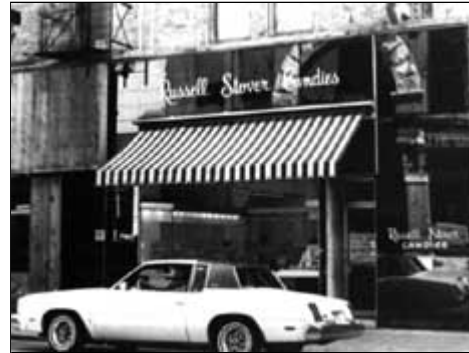
The Russell Stover Candies, Nashville, Tennessee, shows the company's historic use of deep, mirrored violet pigmented structural glass storefronts. Photo: Douglas A. Yorke, AIA.

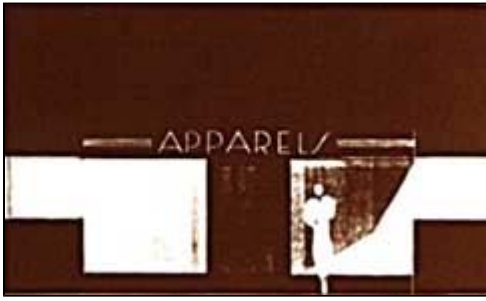
The extensive use of rich, black Vitrolite in this design impressed the judges of the 1935 "Modernize Main Street" competition and the architects were awarded first prize. Photo: Courtesy, The Architectural Record.

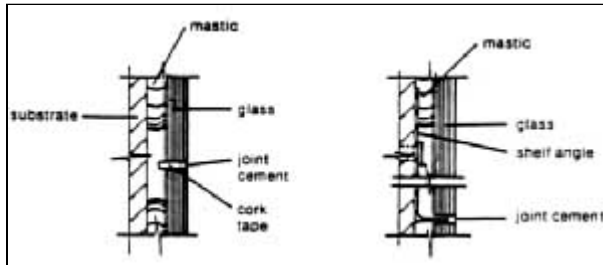
Basic exterior construction details. Photo: Courtesy, Bulletin for the Association for Preservation Technology, 13 (1981).

Essentially, the glass veneer was applied to a dry, smooth, and solid masonry or plaster-on-masonry substrate using an asphaltic masonry adhesive. Manufacturers recommended against affixing the glass directly to wood, either lath or paneling. Glass thicknesses of 1-1/32 inch or 7/16 inch were most common for commercial storefronts.

Shelf angles--18-gauge brass or stainless steel, 3 inch square with a 1/2 inch leg fastened directly to the masonry substrate--were used to provide additional support. Inserted along the bottom edge of the panels, they supported every second course of glass and were thus spaced not more than 3 feet apart. Horizontally, the angles were spaced approximately one every 18 inches with at least two used for any piece.

Actual installation involved applying daubs (2 inches to 3 inches in diameter) of hot asphalt-based mastic adhesive to the glass and then attaching the glass directly to the substrate. Manufacturers of the mastic recommended coverage of about 50 percent of the glass panels. A full 3 inch width of mastic coverage was recommended around detail edges or any holes in the panels. The mastic was applied in a molten state after being melted in an electric "hot cup." (Hot cups

The next step in the installation procedure was to push the glass panel onto the masonry substrate. Every horizontal seam and abutment was separated by a 1/16 inch thick adhesive cork tape recessed from the front surface by 1/8 inch. Vertical edges were kept apart at a uniform 1/32 inch. In either case, the joint opening was then buttered with a joint cement which was colored to match the surrounding glass.

Proper detailing at the edges of the veneer could prolong the life of the pigmented structural glass. For example, to prevent possible chipping and cracking of the glass where it met the sidewalk, a cushion of neoprene or leather was provided and the exposed surface then caulked. The side edges of the glass were detailed in a variety of methods or the glass simply terminated at the desired location with the ends ground smooth. In either case, the edge was secured to the substrate with a mastic and the joints or void filled with joint cement or caulking compound. Where the edge of the glass abutted another material, such as the brickwork of a neighboring storefront, the glass was held back 1/8 inch to 1/4 inch from the adjacent material. The gap was usually filled with pliable caulk to permit expansion and to prevent moisture migration.

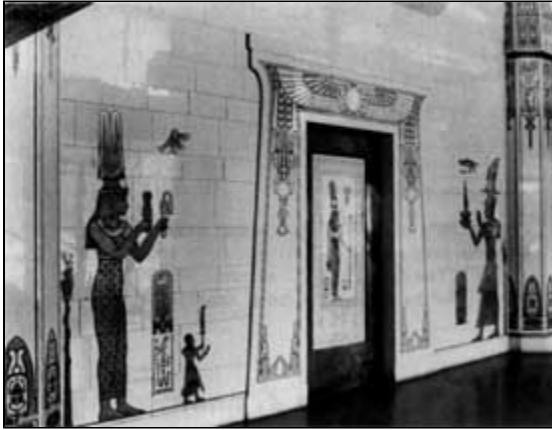
Owners of the Hadley Dean Glass Company Warehouse, St. Louis, preserved the unusual polychrome pigmented structural glass interior lobby. Photo: Paul Marshall.

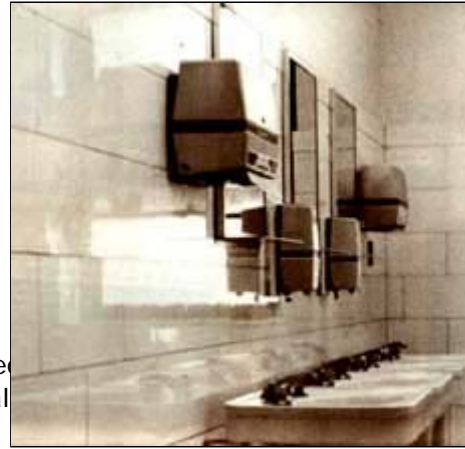
White pigmented structural glass was used in this remodeling of the U.S. Custom House, Denver, Colorado. Photo: Gregory D. Kendrick.

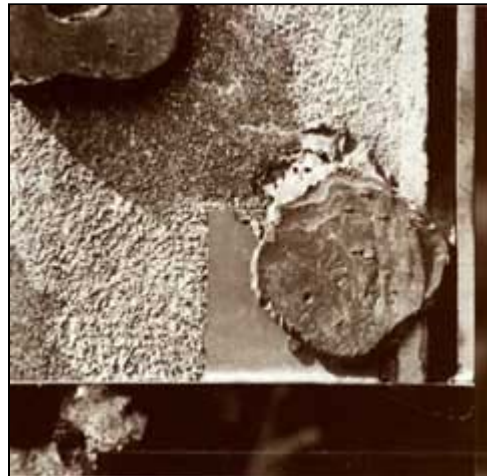
The pigmented structural glass panel has separated and fallen, exposing the substrate and hardened, brittle daubs of mastic. Photo: Douglas A. Yorke, AIA.

Failure due to long-term hardening of the original mastic adhesive has accounted for a substantial loss of pigmented structural glass panels. The petroleum-based mastics normally possessed a 30 to 40 year lifespan. Once flexibility of the adhesive is lost, the glass panels become vulnerable to slippage and eventual destruction.

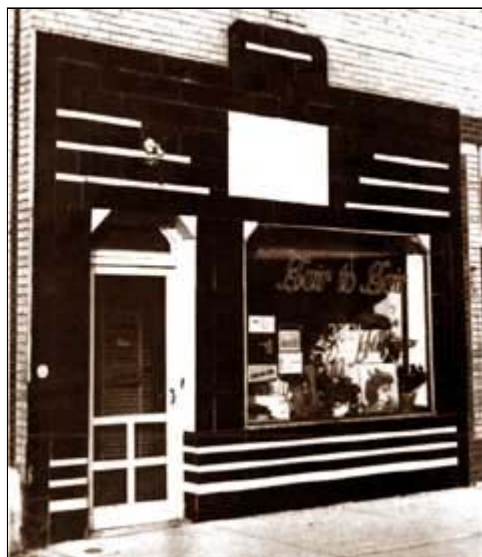
Owners of this small barber shop, Denver, Colorado, have successfully preserved the historic character of their pigmented structural glass storefront by patching the cracked panels with a dark caulking compound. Photo: Gregory D. Kendrick.

A slightly chipped or cracked pigmented structural glass panel left unrepaired will inevitably become a source of water infiltration. Careful patching of those cracks with an appropriately colored, flexible caulk will deter moisture penetration while still allowing expansion and contraction with temperature fluctuations. Although patching is by no means a permanent solution, it will help to protect the material from further damage due to the effects of weather.
