## The Repair and Thermal Upgrading of Historic Steel Windows

Sharon C. Park, AIA

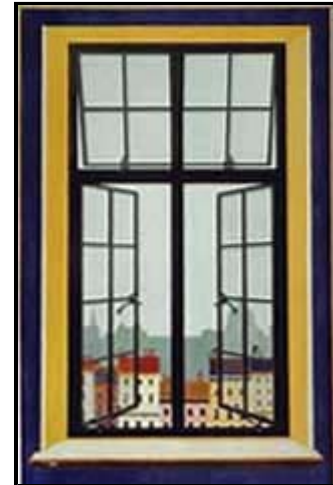
**A NOTE TO OUR USERS:** The web versions of the **Preservation Briefs** differ somewhat from the printed versions. Many illustrations are new, captions are simplified, illustrations are typically in color rather than black and white, and some complex charts have been omitted.

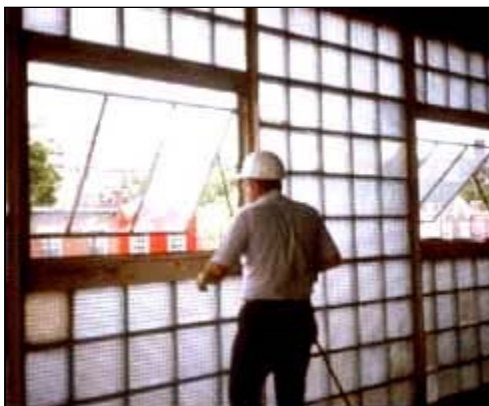
Maintaining historic steel windows for continued use is always recommended.

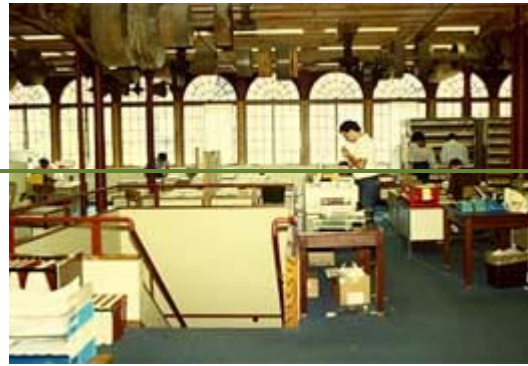
Historic metal windows provide abundant natural light in this rehabilitated industrial space. Photo: NPS files.

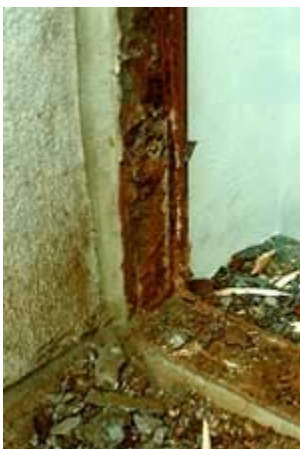
A severely deteriorated frame, such as this, can be replaced in kind. Photo: Henry Chambers, AIA.

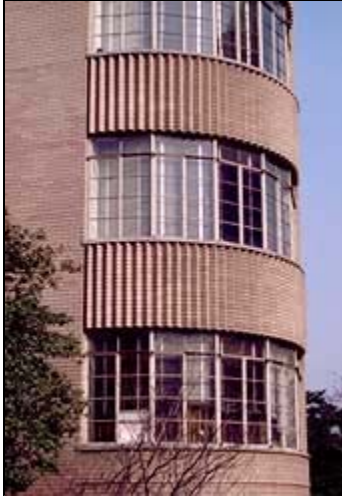
The historic steel sash is shown in place, prior to its removal and replacement with inappropriate aluminum sash (see below). Photo: NPS files.

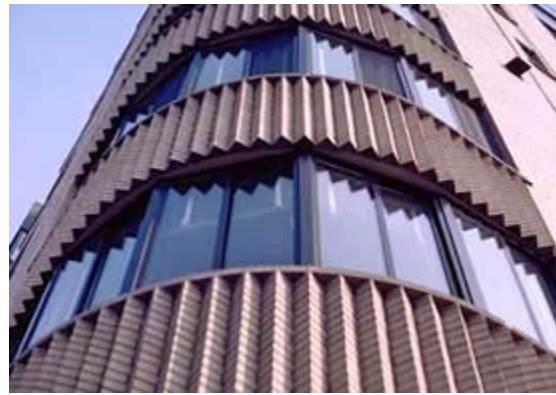
The historic steel sash (see photo above) was removed and replaced with modern aluminum sash, resulting in a negative visual impact on the building's historic character. Photo: NPS files.

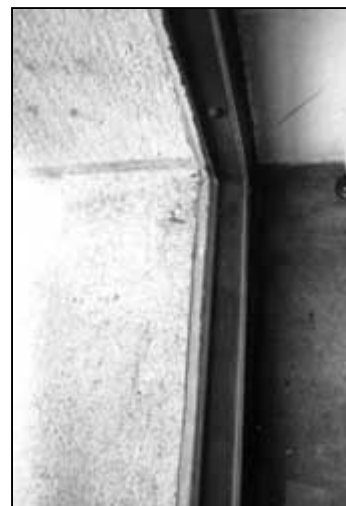
This is a successful replacement in kind of the deteriorated frame shown above. Photo: Henry
