Preservation of Historic Concrete Problems and General Approaches

William B. Coney, AIA

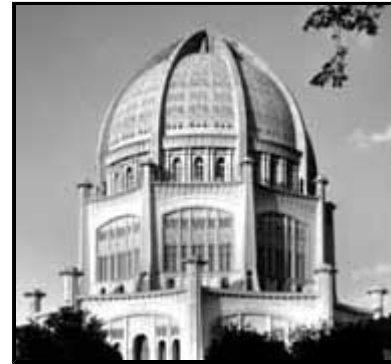
A NOTE TO OUR USERS: The web versions of the **Preservation Briefs** differ somewhat from the printed versions. Many illustrations are new, captions are simplified, illustrations are typically in color rather than black and white, and some complex charts have been omitted.

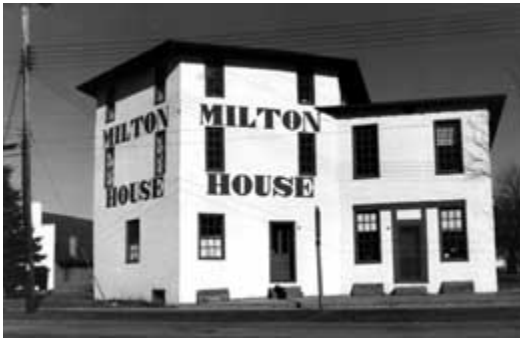
Milton House, Milton, Wisconsin (1844) is an early example of gravel wall construction with 12-to-15-inch thick monolithic concrete walls coated on the exterior with stucco. Photo: William Coney.

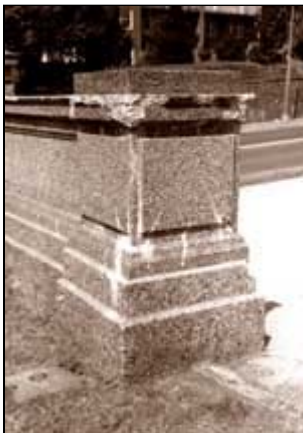
This reinforced concrete pier at Meridian Hill, Washington, DC, has lost much of its projecting molding partly from accidental impact and partly from spalling induced by freeze-thaw action. Photo: NPS files.

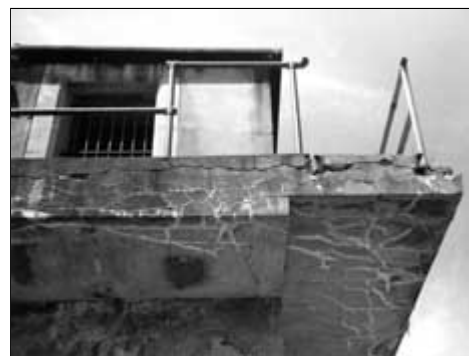
This 1904 reinforced concrete tower (Battery Commander's Station, Fort Washington, Maryland) is showing serious deterioration. Water has penetrated the slab, causing freeze-thaw spalling around the posts and corrosion of the reinforcing bars. Photo: NPS files.

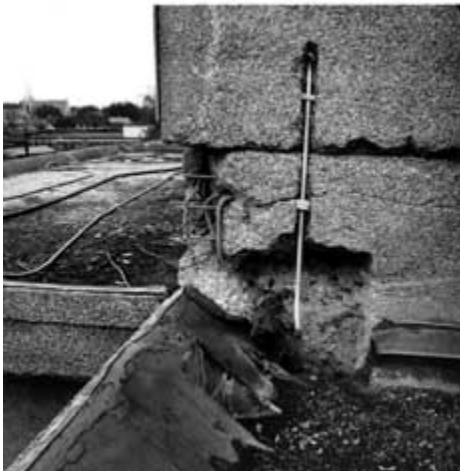
Prior to repairs of the Unity Temple, Oak Park, Illinois (1906), spalled concrete was most noticeable at locations of concentrated rebars. Deteriorated concrete, the 1960s stucco finish, and corrosion were removed by grit blasting. Photo: Robert Bell.

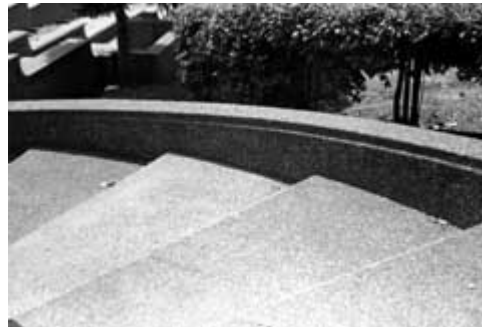
It is important to match the visual qualities, such as color and texture, when repairs or replacement sections are undertaken. Photo: NPS files.

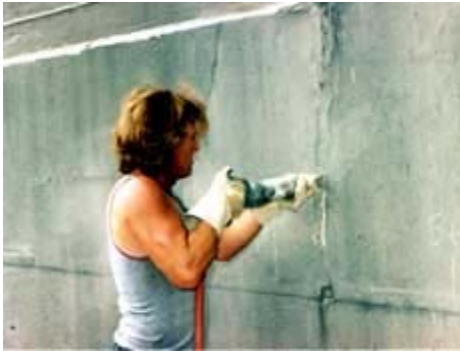
At the Virginia Heating Plant, Arlington, Virginia (1941), narrow cracks needed to be widened to receive concrete patches. Photo: NPS files.

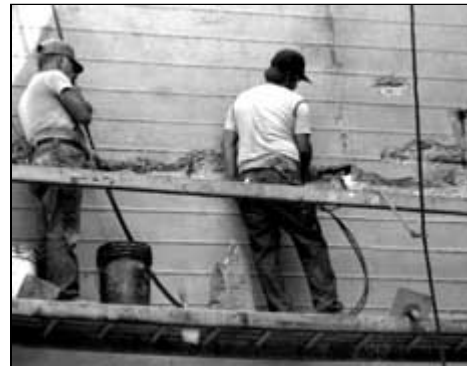
Deteriorated or redundant reinforcing bars are removed after evaluation by a structural engineer. An acetylene torch is being used to cut out the bars. Photo: NPS files.

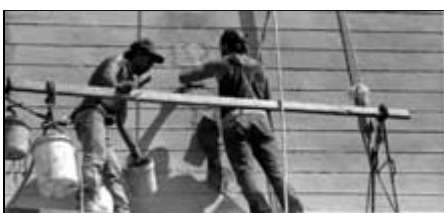
Workmen are applying patching concrete and using a trowel to form

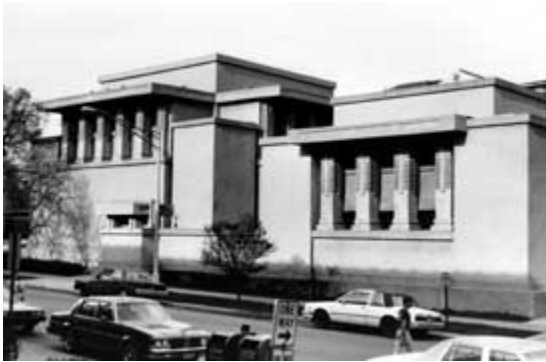
Unity Temple, Oak Park, Illinois (1906). Once all repair work was complete, the entire building was sprayed with a concrete mixture consisting of pea-gravel and sand, which was then hand-trowled. Finally, the building was grit-blasted to remove the cement paste and reproduce the exposed aggregate finish. Photo: NPS files.

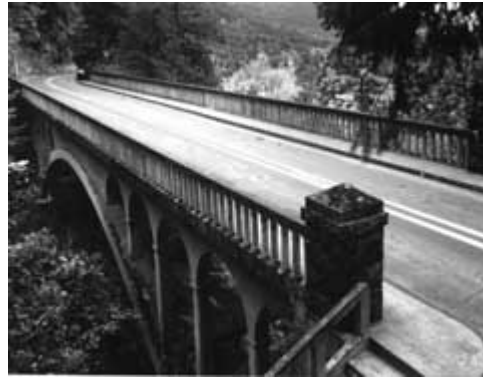
The new concrete spindles have been installed. This sensitive rehabilitation of the Young Creek Bridge (1914), part of Oregon's Columbia River Highway, re-used the historic concrete cap railing and stone piers because they were still in good condition. Photo: James Norman.
