The Use of Substitute Materials on Historic Building Exteriors

Sharon C. Park, AIA

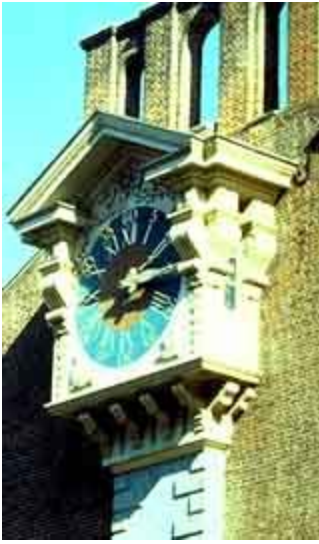
In the reconstruction of the clock tower at Independence Hall, the substitute materials used were cast stone and wood with fiberglass and polyester bronze ornamentation. Photo: NPS files.

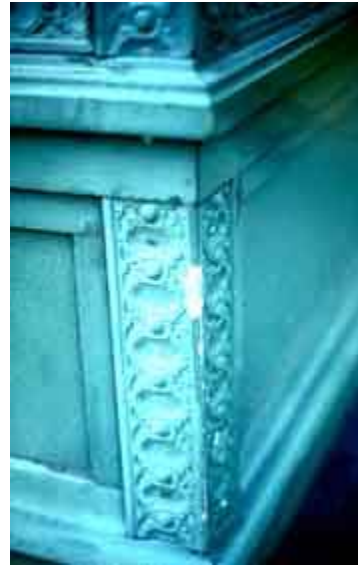
Substitute materials need to be located with care to avoid damage. The fiberglass column base has chipped, whereas the historic cast iron would have remained sound. Photo: NPS files.

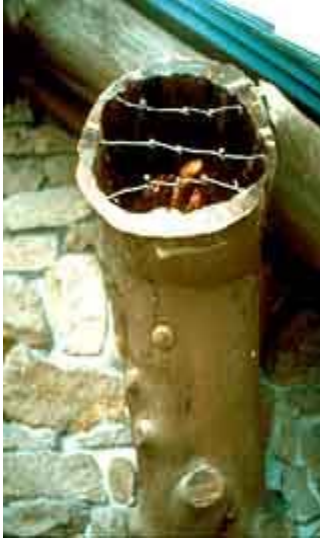
The core of a deteriorated wood outrigger was first drilled out. Photos (left and right): Courtesy, Harrison Goodall.

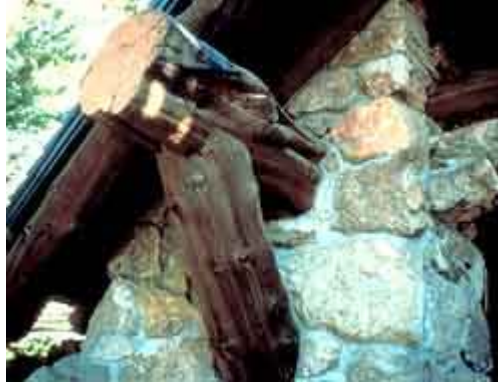
An inert material was injected into the hollow outrigger, permitting the outer wood to be retained and preserved.

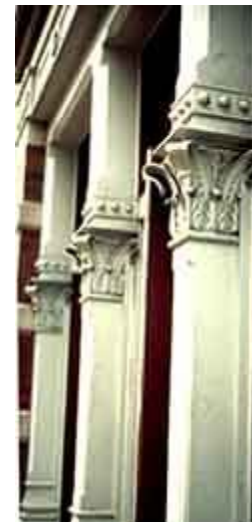
Cast aluminum has been used as a replacement material for cast iron. Photo: NPS files.

Application: Cast aluminum can be a substitute for cast iron or other decorative elements. This would include grillwork, roof crestings, cornices, ornamental spandrels, storefront elements, columns, capitals, and column bases and plinth blocks. If not self-supporting, elements are generally screwed or bolted to a structural frame. As a result of galvanic corrosion problems with dissimilar metals, joint details are very important.

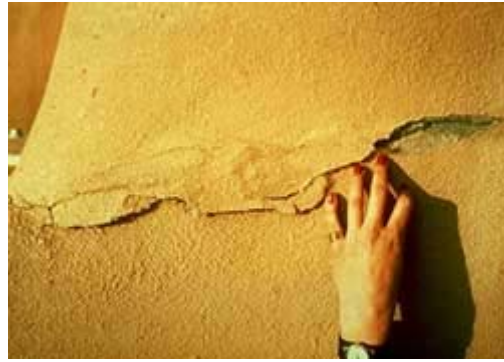
A waterproof coating is an inappropriate substitute material to apply to adobe as it seals in moisture and may result in spalling. Photo: NPS files.

Substitute materials, notably the masonry ones, may be more water-absorbent than the historic material. If this is visually distracting, it may be appropriate to apply a protective vapor-permeable coating on the substitute material. However, these clear coatings tend to alter the reflectivity of the material, must be reapplied periodically, and may trap salts and moisture, which can in turn produce spalling. For these reasons, they are not recommended for use on historic materials.

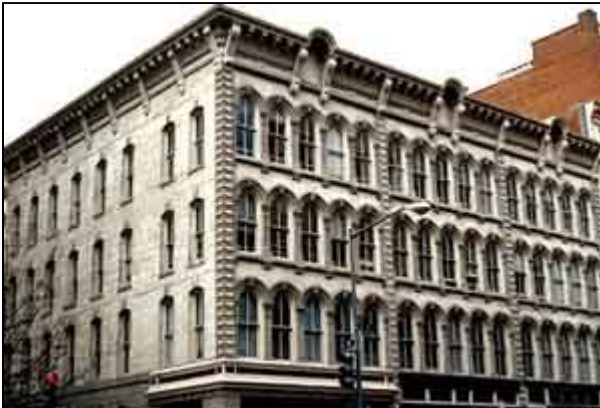
The historic cornice was successfully replaced with a fiberglass cornice. Photo: NPS files.
