The Repair and Replacement of Historic Wooden Shingle Roofs

Sharon C. Park, AIA

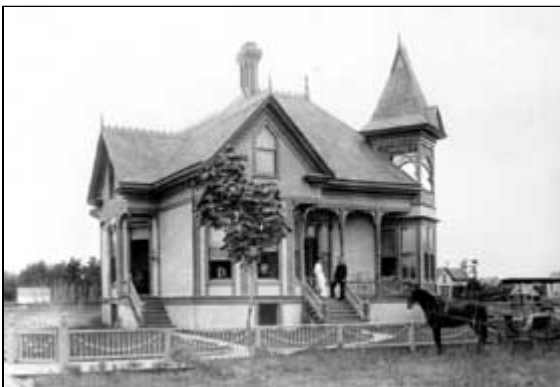
Readily available and inexpensive sawn shingles were used not only for roofs, but for gables and wall surfaces. Photo: Lane County Historical Society.

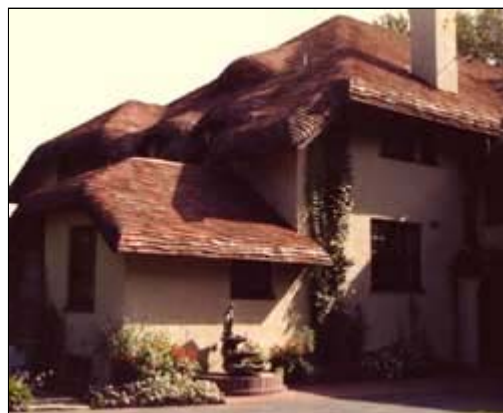
With the popularity of the revival of historic styles in the late 19th and early 20th centuries, a new technique was developed to imitate English thatch roofs. Photo: C.H. Roofing.

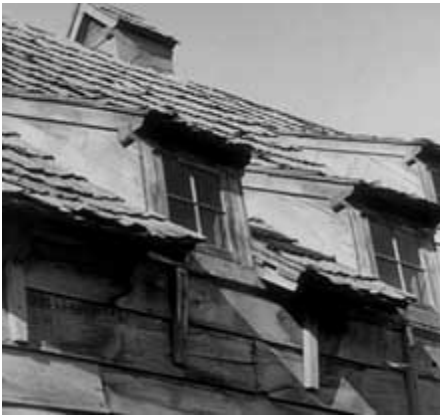
The long, biaxially tapered handsplit shingles are overlapped both vertically and horizontally. Photo: NPS files.

Not all shingles were laid in evenly spaced, overlapping, horizontal rows. In various regions of the country, there were distinct installation patterns; for example, the biaxially-tapered long shingles occasionally found in areas settled by the Germans. These long shingles were overlapped on the side as well as on top. This formed a ventilation channel under the shingles that aided drying. Because ventilation of the shingles can prolong their life, roofers paid attention to these details.

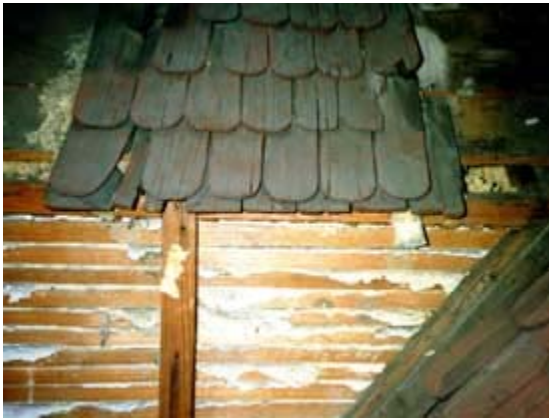
These weathered historic 19th-century handsplit and dressed shingles were found in place under a later altered roof. See also, below. Photo: John Ingle.

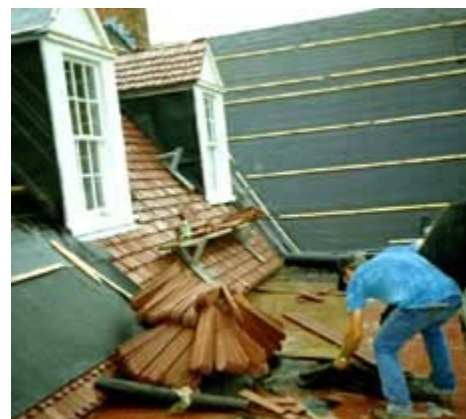
The replacement shingles matched the historic shingles and were of such high quality that little hand dressing was needed at the site. Photo: John Ingle.

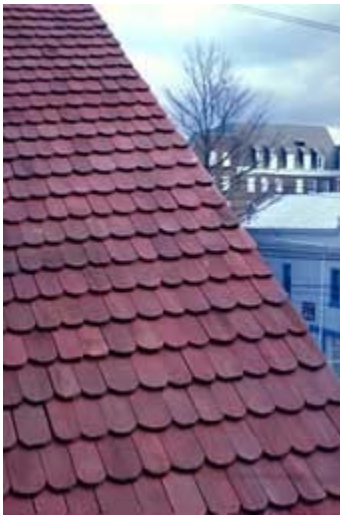
New rounded butt sawn shingles, with a smooth finish and red oxide stain, were used to replace the deteriorated shingles. The varying widths, between 4" and 7" will keep them from curling and cupping. Exposure length was determined from historic nail patterns on the historic spaced sheathing below. Photo: NPS files.

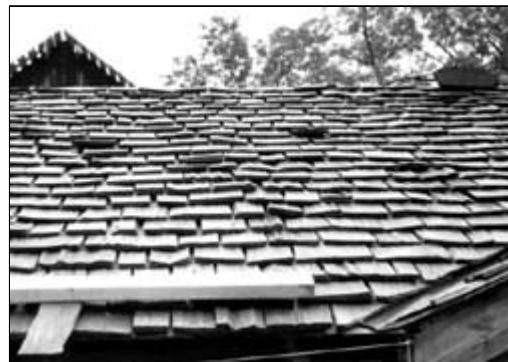
These commercially available roofing products with rustic split faces are not appropriate for historic preservation projects. Photo: NPS files.

As seen from the Shingle and Shake chart, few of the commercially available shakes can be used without some modification or careful specification. Some, such as heavy shakes with a corrugated face, should be avoided altogether. While length, width, and butt configuration can be specified, it is more difficult to ensure that the thickness and the texture will be correct. For that reason, whatever shingle or shake is desired, it is important to view samples, preferably an entire bundle, before specifying or ordering. If shingles are to be trimmed at the site for special conditions, such as fanned hips or swept valleys, additional shingles should be ordered.
