The Preservation of Historic Barns

Michael J. Auer

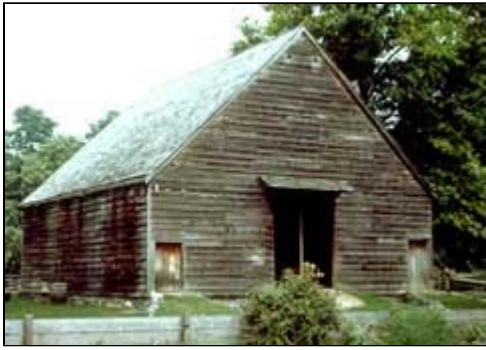
A gable roof, center wagon doors with pent roof, stock door at the corners, and horizontal clapboarding are all typical features of the Dutch barn. Photo: S. Matson.

On the narrow end the Dutch barn features center doors for wagons and a door to the stock aisles on one or both of the side ends. A pent roof (or pentice) over the center doors gave some slight protection from the elements. The siding is typically horizontal, the detailing simple. Few openings other than doors and traditional holes for martins puncture the external walls. (3) The appearance is of massiveness and simplicity, with the result that Dutch barns seem larger than they actually are.

To many observers the heavy interior structural system is the most distinctive aspect of the Dutch barn. Mortised, tenoned and pegged beams are arranged in "H"-shaped units that recall church interiors, with columned aisles alongside a central space (here used for threshing). This interior arrangement, more than any other characteristic, links the Dutch barn with its Old World forebears. The ends of cross beams projecting through the columns are often rounded to form "tongues," a distinctive feature found only in the Dutch barn.

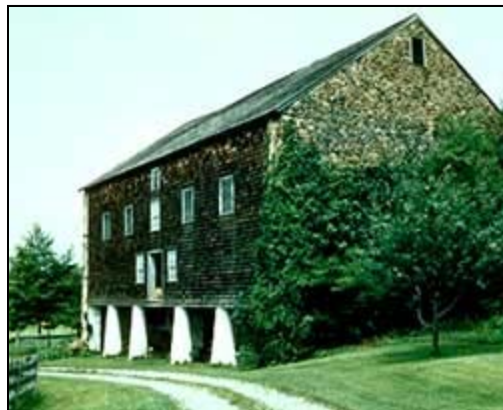
A gently sloping roadbed shows the "bank," from which bank barns get their name. Photo: NPS files.

The bank barn gets its name from a simple but clever construction technique: the barn is built into the side of a hill, thus permitting two levels to be entered from the ground. The lower level housed animals, the upper levels served as threshing floor and storage. The hillside entrance gave easy access to wagons bearing wheat or hay. (Fodder could also be dropped through openings in the floor to the stabling floor below.) The general form of the bank barn remained the same whether it was built into a hillside or not. Where a hill was lacking, a "bank" was often created by building up an earthen ramp to the second level.

Bank barns were ordinarily constructed with their long side, or axis, parallel to the hill, and on the south side of it. This placement gave animals a sunny spot in which to gather during the winter. To take further advantage of the protection its location afforded, the second floor was extended, or cantilevered, over the first. The overhang sheltered animals from inclement weather. The extended forebay thus created is one of the most characteristic features of these barns. In some bank barns, the projecting beams were not large enough to bear the entire weight of the barn above. In these cases, columns or posts were added beneath the overhang for structural support.

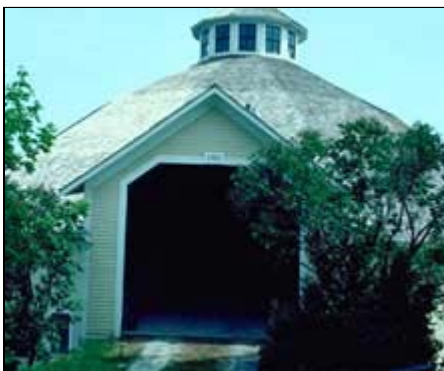
Circular barns are found throughout the country. This round barn, dated 1910, is in Vermont. It is 80 feet in diameter. Photo: Jay White.

Round barns were promoted for a number of reasons. The circular form has a greater volume-to-surface ratio than the rectangular or square form. For any given size, therefore, a circular building will use fewer materials than other shapes, thus saving on material costs. Such barns also offer greater structural stability than rectangular barns. And because they can be built with self-supporting roofs, their interiors can remain free of structural supporting elements, thereby providing vast storage capabilities. The circular interior layout was also seen as more efficient, since the farmer could work in a continuous direction.

In general, multi-sided barns--frequently of 12 or 16 sides--are earlier than "true round" barns. Earlier examples also tend to be wood sided, while later ones tend to be brick or glazed tile. Interior layouts also underwent an evolution. Early round barns placed cattle stanchions on the first floor, with the full volume of the floor above used for hay storage. In later barns, the central space rose from the ground floor through the entire building. Cattle stanchions arranged around a circular manger occupied the lower level; the circular wagon drive on the level above permitted hay to be unloaded into the central mow as the wagon drove around the perimeter. In the last stage of round barn development, a center silo was added when silos became regular features on the farm (in the last decades of the nineteenth century). In some cases, the silo projected through the roof.

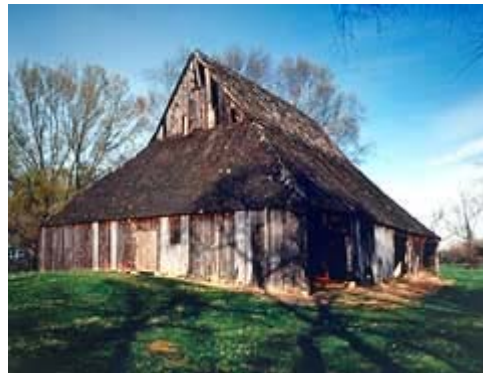
This 19th century tobacco barn, characterized by its steep gable-on-hip roof, is located in Prince Georges County, Maryland. Photo: Jack E. Boucher, NPS.

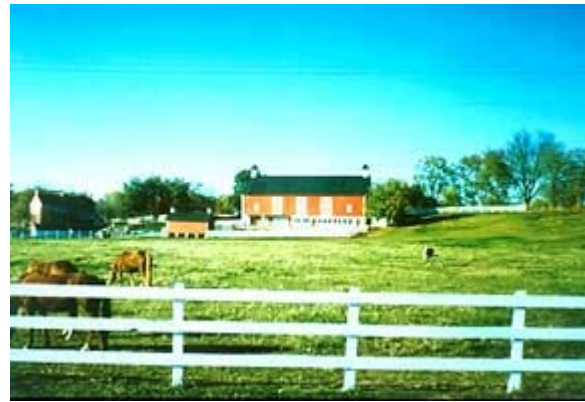
A barn is integral with its setting--orchards, ponds, fencing, streams, country roads, windmills, and silos. Photo: Jack E. Boucher, HABS Collection, NPS.

Setting. Setting is one of the primary factors contributing to the historic character of a barn. Farmers built barns in order to help them work the land; barns belong on farms, where they can be seen in relation to the surrounding fields and other structures in the farm complex. A barn crowded by suburbs is not a barn in the same sense as is a barn clustered with other farm buildings, or standing alone against a backdrop of cornfields. Hence, the preservation of barns should not be divorced from the preservation of the setting: farms and farmland, ranches and range, orchards, ponds, fields, streams and country roads.

Other important elements of setting include fences, stone walls, roads, paths, barnyards, corrals, and ancillary structures such as windmills and silos. (Silos, indeed, have become so closely associated with barns as nearly to have lost their "separate" identities.) These features help place the building in the larger agricultural context, relating it to its purpose in the overall rural setting.

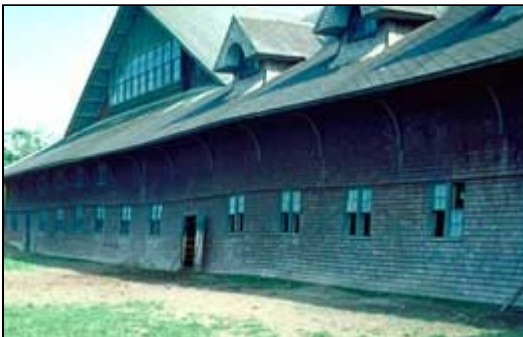
This enormous late 19th century barn in Shelburne, Vermont, displays a complexity

and sophistication of roofing elements. See interior, below. Photo: NPS files.

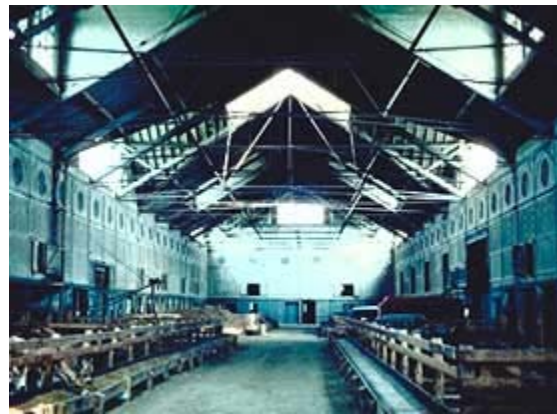
The interior of the barn in Shelburne, Vermont, is a magnificent space that included an overhead hay loft with tracks that allowed workers to drop hay to the floor below. Photo: NPS files.

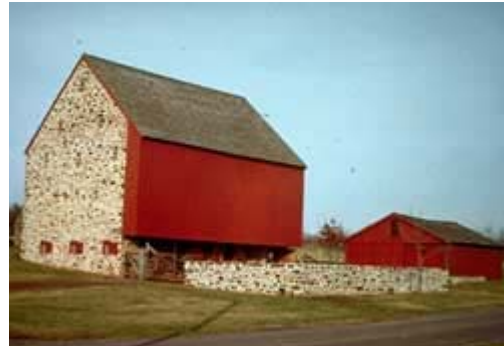
This well-maintained late 18th century barn is located in Worcester, Pennsylvania. Note the use of indigenous stone in the structure and surrounding fencing. Photo: Robert McCullough.

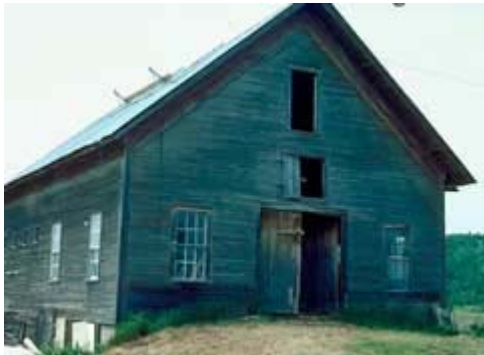
This horse barn, ca. 1875, is in Stowe, Vermont. Its cupola has been removed for repair. Photo: NPS files.

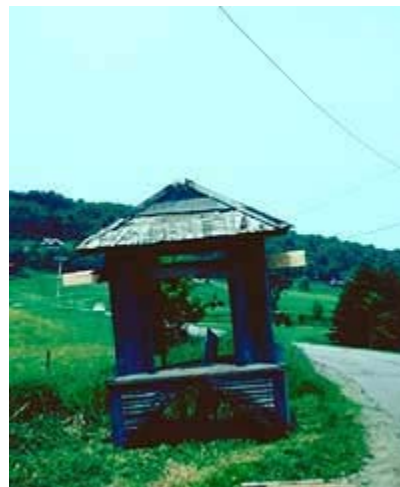
This cupola will be repaired and returned to the horse barn roof (see photo, above). Photo: NPS files.

Exterior. In addition to the roof and the foundation, other exterior elements may need repair, including siding, brick and stonework, dormers and cupolas, windows and doors. Shutters may be falling off, doors may need to be rehung, and missing louvers replaced.
