## The Preservation and Repair of Historic Log Buildings

**Bruce D. Bomberger**

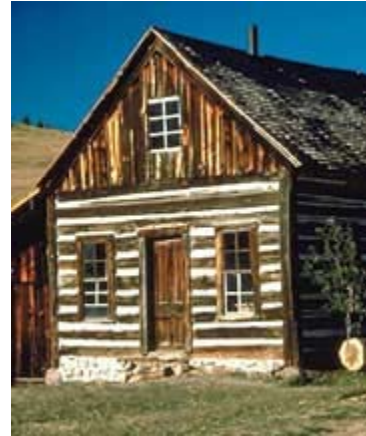
The entrance door centered in the gable end in this late-19th century log building is a typical feature of the Rocky Mountain Cabin style. Photo: NPS files.

A somewhat different form evolved in the West around the middle of the 19th century which became especially distinctive of the Rocky Mountain cabin. While the entrance doorway to most earlier log houses was generally placed beneath the eaves, as a means of adapting to the greater snowfall in the Rockies, here the entrance was placed in the gable end, and sometimes protected from roof slides by a porch supported by two corner posts created by an extension of the roof beyond the gable wall.

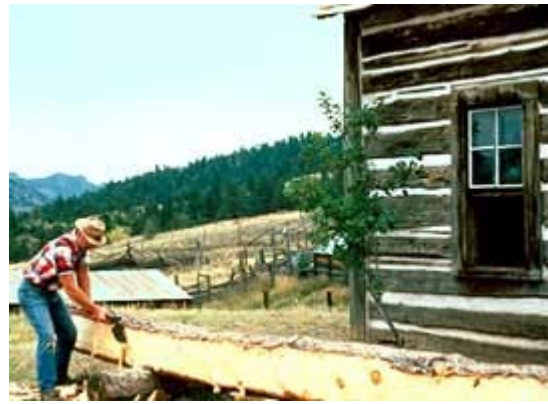
A log to replace the deteriorated sill is being hewn in the traditional manner with a broad axe. Photo: NPS files.

A replacement log should be obtained to match the wood species of the original being removed. If it is a hewn log, then the replacement must be hewn to replicate the dimensions and tool marks of the original. If the same wood species cannot be obtained in the original dimensions, a substitute species may have to be used, and may even be preferable in some instances if a more durable wood

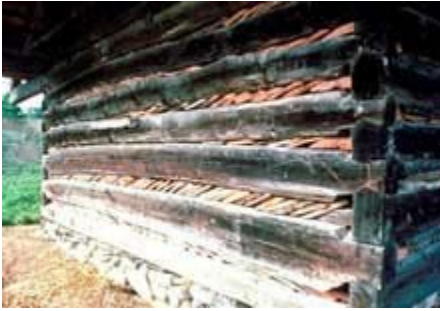
Stone or wood strips served to fill in the chinking areas over which the daubing was applied. Photo: NPS files.

Sections of wood chinking which are gone or cannot be made weathertight should be replaced with same-sized species saplings or quarter poles cut to fit. Generally, unless bark was used originally, it should be removed before nailing the new wood chinking replacements tightly into place.

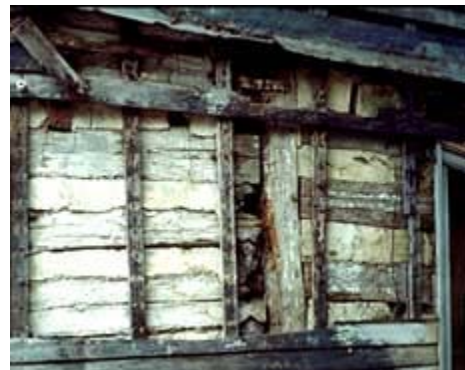
Once the siding is gone, the logs may rapidly deteriorate unless another protective treatment is applied. Photo: NPS files.

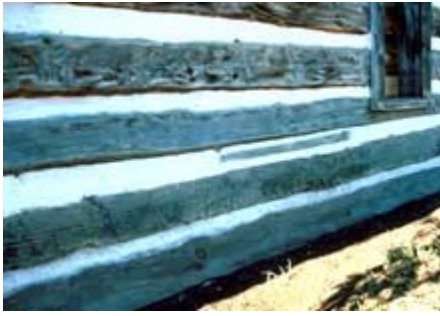
The new sill matches the original and is a compatible replacement. Photo: NPS files.

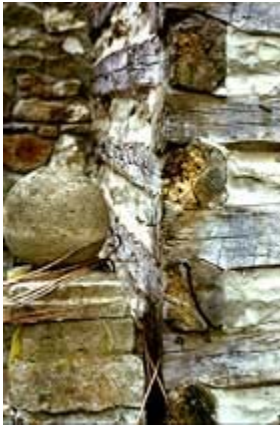
Daubing composed entirely of portland cement is never appropriate to use on a historic log building. Photo: NPS files.

Portland cement was a part of the original daubing used in many late 19th and early 20th century log buildings, and is therefore appropriate to include in repairing buildings of this period. Although a small amount of portland cement may be added to a lime, clay and sand mix for workability, there should not be more than 1 part portland cement to 2

parts of lime in daubing mixes intended for most historic log buildings. Portland cement tends to shrink and develop hairline cracks, and retain moisture, all of which can be potentially damaging to the logs.
