The Maintenance and Repair of Architectural Cast Iron

John G. Waite, AIA

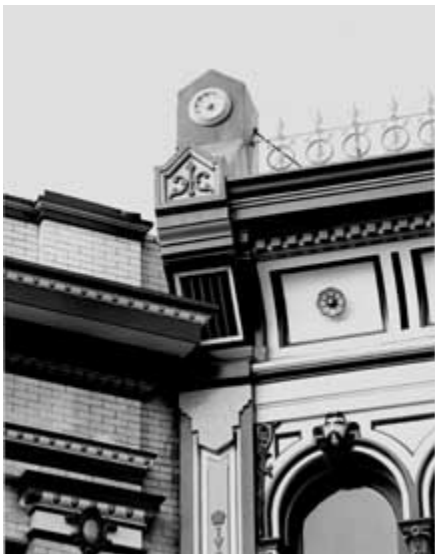
This shows a detail of a polychromed cast-iron facade in Petaluma, California, 1886 (O'Connell and Lewis, Architectural Iron Works, San

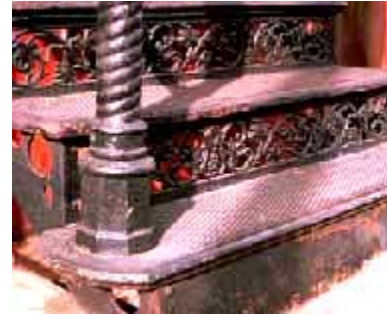
The risers on these cast iron steps feature a highly decorative pattern. Photo: NPS files.

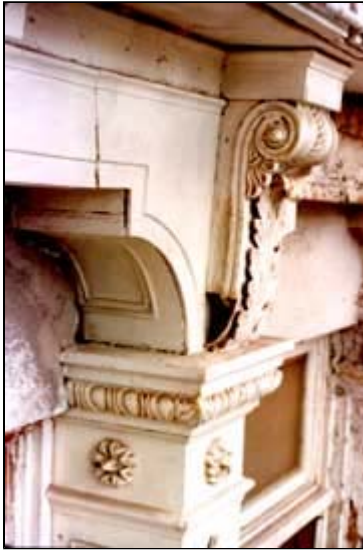
Structural crack, gaps at joints between components, and a large opening where part of the console bracket is missing are the problems evident in this cast-iron assembly. Photo: Ford, Powell & Carson.

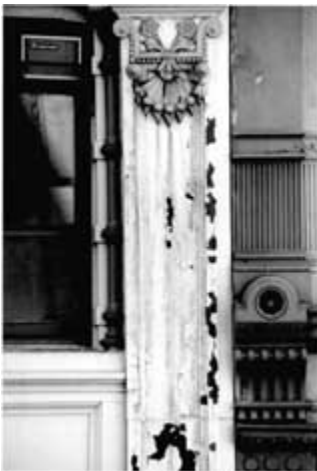
On this building, a strong alkaline paint remover was used, and apparently was not adequately rinsed or neutralized. Over a period of months, the newly applied paint began to peel and streaks of rust appeared on the iron. Photo: Kim Lovejoy.

Chemical paint removal using alkaline compounds, such as methylene chloride or potassium hydroxide, can be an effective alternative to abrasive blasting for removal of heavy paint buildup. These agents are often available as slow-acting gels or pastes. Because they can cause burns, protective clothing and eye protection must be worn. Chemicals applied to a non-watertight facade can seep through crevices and holes, resulting in damage to the building's interior finishes and corrosion to the backside of the iron components. If not thoroughly neutralized, residual traces of cleaning compounds on the surface of the iron can cause paint failures in the future. For these reasons, field application of alkaline paint removers and acidic cleaners is not generally recommended.

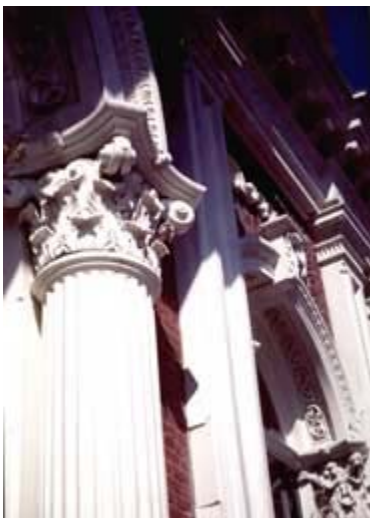
Fiberglass columns and aluminum capitals were installed to replicate the ornamental features on the east facade of the New Market Theater in Portland, Oregon.

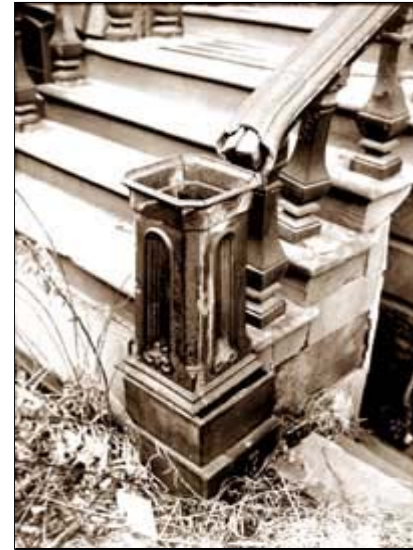
In an effort to repair the stair railing, concrete was poured around the wood spacer inside the railing ceiling. Water penetrated the railing and reacted with the concrete to accelerate the corrosion of the iron. Photo: John G. Waite.

The internal voids of balusters, newel posts, statuary, and other elements should not be filled with concrete; it is an inappropriate treatment that causes further problems. As the concrete cures, it shrinks, leaving a space between the concrete and cast iron. Water penetrating this space does not evaporate quickly, thus promoting further rusting. The corrosion of the iron is further accelerated by the alkaline nature of concrete. Where cast-iron elements have been previously filled with concrete, they need to be taken apart, the concrete and rust removed, and the interior surfaces primed and painted before the elements are reassembled.

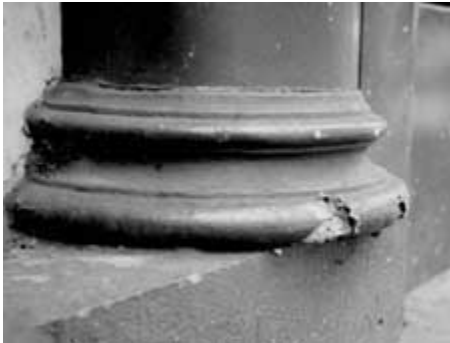
This lightweight fiberglass column at street level sustained damage from impact within a few years of installation. Photo: Building Conservation Associates.

Reinforced polyester, commonly known as fiberglass, is often used as a lightweight substitute for historic materials, including cast iron, wood, and stone. In its most common form, fiberglass is a thin, rigid, laminate shell formed by pouring a polyester resin into a mold and then adding fiberglass for reinforcement. Like epoxies, fiberglass is non-corrosive, but is susceptible to ultraviolet degradation. Because of its rather flimsy nature, it cannot be used as a substitute for structural elements, cannot be assembled like cast iron and usually requires a separate anchorage system. It is unsuitable for locations where it is susceptible to damage by impact, and is also flammable.
