## The Repair, Replacement & Maintenance of Historic Slate Roofs

Jeffrey S. Levine

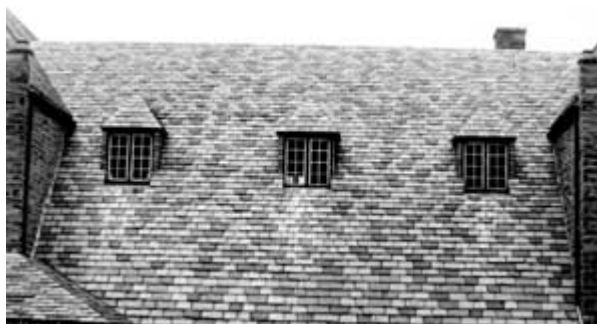
This graduated slate roof is composed of large, thick slates at the eave which are reduced in size and thickness as the slating progresses to the ridge. Photo: Jeffrey S. Levine.

Graduated slate roofs were frequently installed on large institutional and ecclesiastical structures. The slates were graduated according to thickness, size, and exposure, the thickest and largest slates being laid at the eaves and the thinnest and smallest at the ridge. Pleasing architectural effects were achieved by blending sizes and colors.

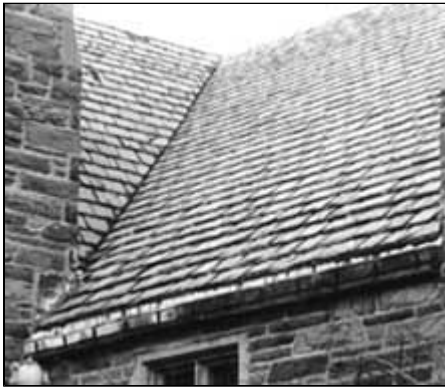
Valleys are formed at the internal angle of two roofing slopes. Flashing is often placed under the slate to increase moisture protection at this vulnerable joint. Photo: Jeffrey S. Levine.

Two types of valleys were traditionally employed, the **open valley** and the **closed valley**. The open valley is lined with metal over which slates lap only at the sides. Closed valleys are covered with slate and have either a continuous metal lining or metal flashing built in with each course. Open valleys are easier to install and maintain, and are generally more watertight than closed valleys. Round valleys are a type of closed valley with a concave rather than Vshaped section. Given the broader sweep of the round valley, it was not uncommon for roofers to interweave asphalt saturated felts rather than copper sheet in the coursing in order to cut costs.

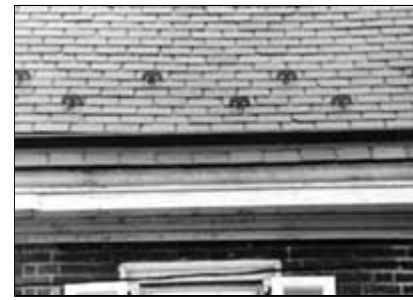
Eave details include snow guards, snow boards, and gutter treatments. Snow guards are generally used in areas where the ice and snow accumulate to avoid dangerous slides from the roof. Photo: Jeffrey S. Levine.

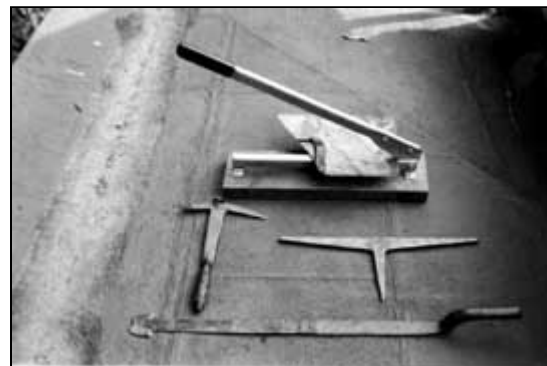
These traditional slater's tools are used to cut and trim, hammer, measure, and rip out nails. Photo: Jeffrey S. Levine.

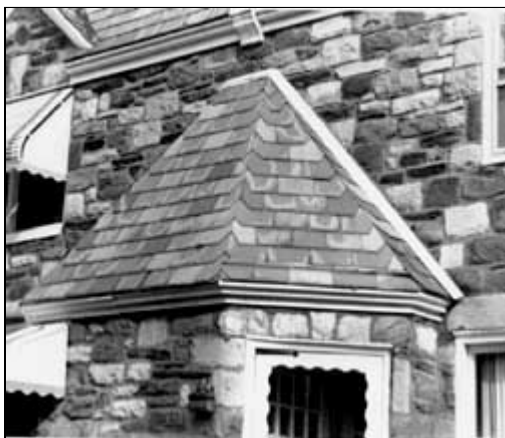
The white blotches on these Pennsylvania Soft-Vein slates indicate areas where gypsum is leaching out onto the surfaces of the slates. Photo: Jeffrey S. Levine.

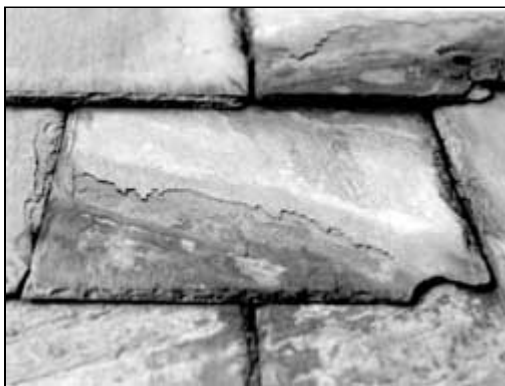
Paper thin lamination can be seen flaking off this weathered, 120 year piece of Pennsylvania Hard-Vein slate. Photo: Jeffrey S. Levine.

The natural weathering of roofing slate manifests itself as a slow process of chipping and scaling along the cleavage planes. Paper thin laminations flake off the surface of the slate and the slate becomes soft and spongy as the inner layers begin to come apart, or delaminate. The nature of the sound given off by a slate when tapped with one's knuckles or slating hammer is a fair indication of its condition.

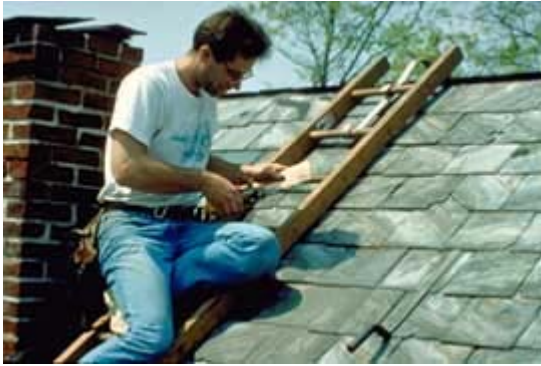
After removing the deteriorated slate and sliding the new slate into place, it is secured with a copper nail. A copper bib (shown here) is formed to protect the newly created nail hole. Finally, a slate hammer is used to push the bib in place over the nail head. Photo: Jeffrey S. Levine.

To prevent water penetration through the newly created nail hole, a piece of copper with a friction fit, measuring roughly 3" (7.5 cm) in width and 8" (20 cm) in length, is slid lengthwise under the joint between the two slates located directly above the new slate and over the nail. Alternate methods for securing the replacement slate include the use of metal hooks, clips, and straps that are bent over the tail end of the slate. The application of roofing mastic or sealants to damaged slates should not be considered a viable repair alternative because these materials, though effective at first, will eventually harden and crack, thereby allowing water to enter.

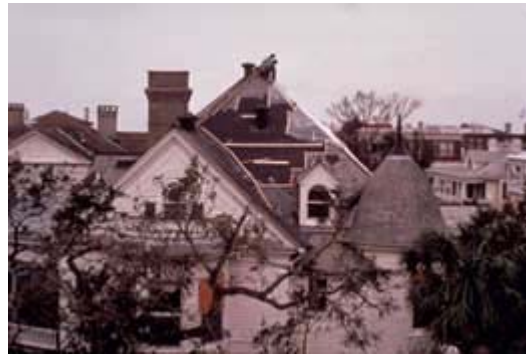
After a hurricane or other natural disaster, it may be necessary to stabilize a roof temporarily until materials can be obtained and a qualified roofing contractor hired. Significant slate roofs should not be stripped off and replaced with asphalt shingles. Photo: NPS files.

In emergency situations, such as when severe hurricanes or tornadoes blow numerous slates off the roof, a temporary roof covering should be installed immediately after the storm to prevent further water damage to the interior of the building and to permit the drying out

process to begin. Heavy gauge plastic and vinyl tarpaulins are often used for this purpose, though they are difficult to secure in place and can be blown off in high winds. Roll roofing, carefully stitched in to areas of the remaining roof, is a somewhat more functional solution that will allow sufficient time to document the existing roof conditions, plan repairs, and order materials.

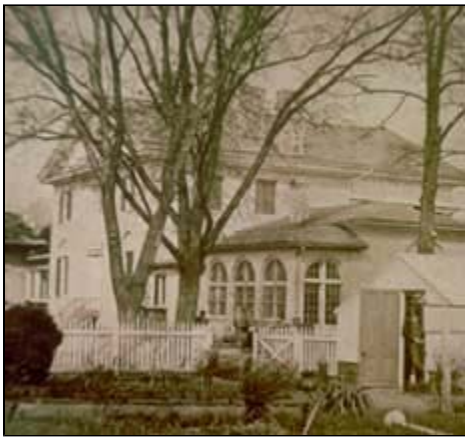
Prior to a replacing a roof, historical documentation is gathered (such as photo documentation) to determine the roof configuration. Photo: NPS files.
