The Preservation and Repair of Historic Clay Tile Roofs

Anne E. Grimmer and Paul K. Williams

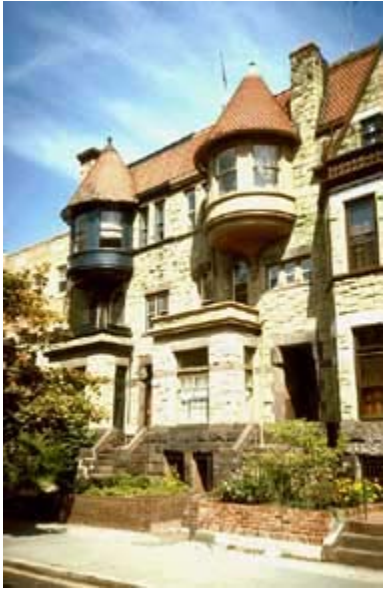
Clay tile was a popular roofing material for residential structures during the Romanesque Revival period. Photo: NPS files.

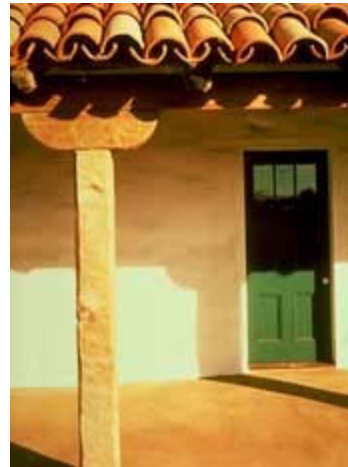
Tapered barrel clay roof tiles were custom made for the restoration of the 1820s Indian barracks at Mission Santa Cruz in California. Photo: NPS files.

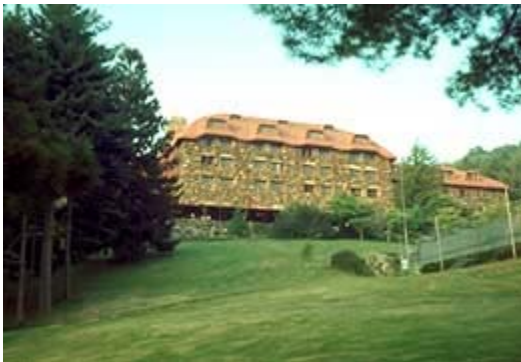
The clay tile roof is important in defining the character of the c. 1917 Mission-style Grove Park Inn, Asheville, North Carolina. Photo: NPS files.

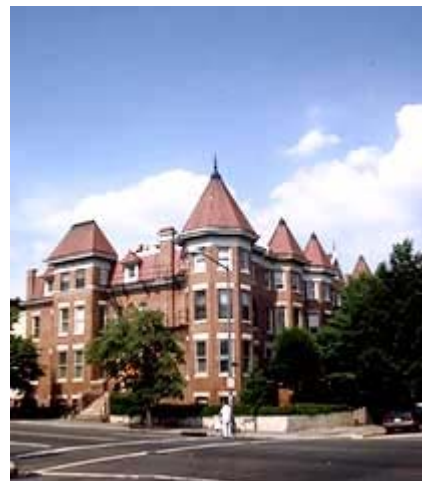
Clay tiles emphasize the prominence of the peaked roofs of these late 19th century rowhouses. Photo: NPS files.

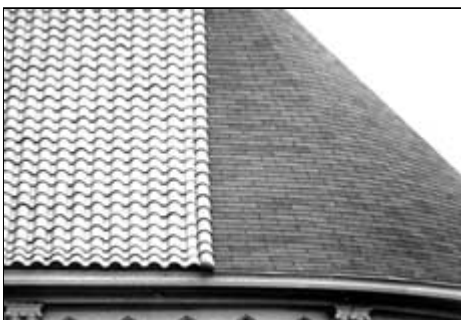
Asphalt shingles are an incompatible replacement substitute for the original Spanish clay tiles. Photo: NPS files.

The most important repair to avoid is replacing broken or missing roof tiles on a historic building with materials other than matching natural clay tiles. Concrete, metal or plastic tiles are generally not appropriate substitutes for clay roofing tiles. They lack the natural color variations of clay tile, and they do not have the same texture, shape, thickness or surface irregularities.

Although much concrete tile and composition tile is produced to resemble the general shape, if not the exact profile, of clay roofing tiles, concrete tile is generally too thick and also lacks the range of colors inherent in natural clay tile. Concrete tile is not a compatible substitute material to repair or replace individual historic clay tiles.

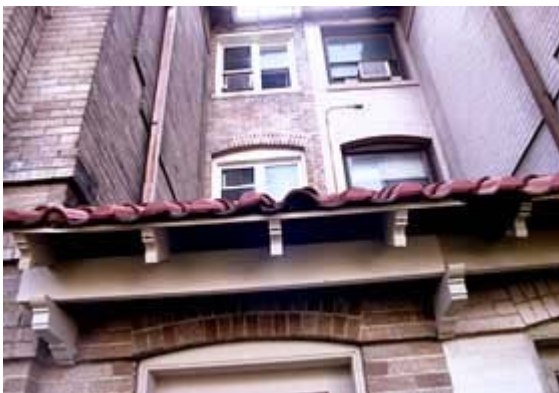
An eave closure or *birdstop* to keep out birds is notably absent from the replacement tile in the center of the bottom row. Photo: NPS files.

Field and Specialty Tile. The tiles that cover the majority of the flat surface of the roof are called field tile. Some roof shapes, particularly conical towers or turrets, require tiles of graduated sizes, and some shapes or patterns of field tile also require specially shaped finish tiles to complete the roof covering package. Other uniquely-shaped tiles were made to fit odd-shaped spaces and places including dormers and valleys, roof hips, rakes, ridges and corners. There are also finish tiles that fulfill certain needs, such as eave closures or clay plugs called "birdstops." These are intended to keep out snow and rain, and birds from nesting in the voids under the bottom row

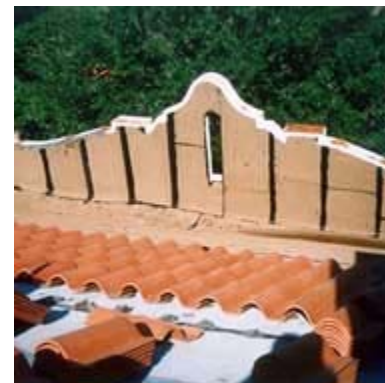
Projections on the underside of these replacement Spanish clay tiles help them adhere to the cement mortar on the roof sheathing. Photo: NPS files.
