Mothballing Historic Buildings

Sharon C. Park, AIA

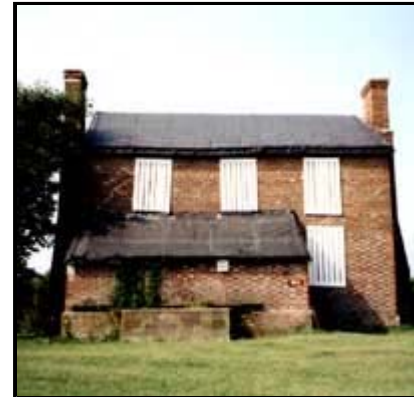
A NOTE TO OUR USERS: The web versions of the **Preservation Briefs** differ somewhat from the printed versions. Many illustrations are new, captions are simplified, illustrations are typically in color rather than black and white, and some complex charts have been omitted.

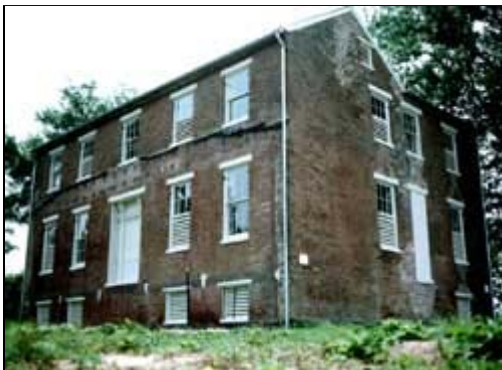
This building has been successfully mothballed for 10 years because the roof and walls were repaired and structurally stabilized, ventilation louvers added, and the property maintained. Photo: NPS files.

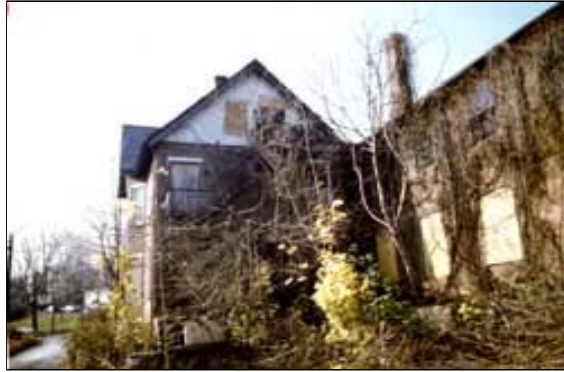
Boarding up without adequate ventilation and maintenance has accelerated deterioration of this property. Photo: NPS files.

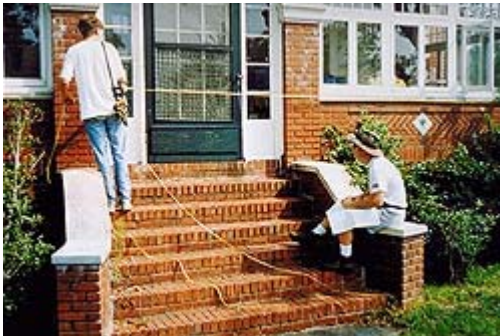
Documenting a building's history and assessing its condition provide information to set priorities for stabilization and repair, prior to mothballing. Photo: NPS files.

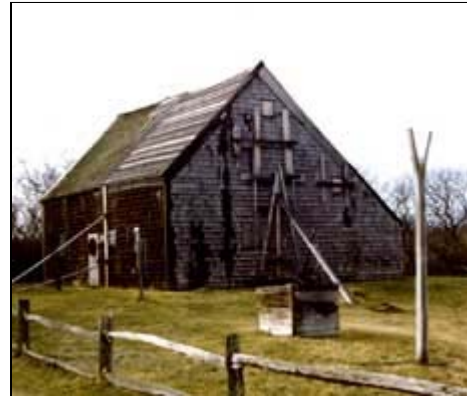
Buildings seriously damaged by storms or deterioration may need to be braced before architectural evaluations can be made. Photo: John Milner Architects. Photo: NPS files

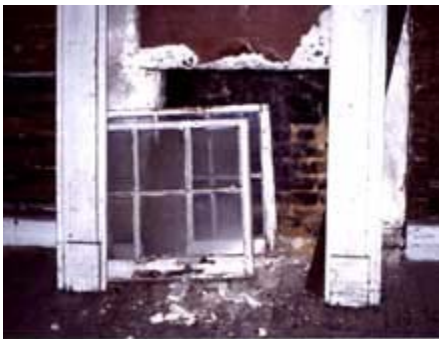
Loose or detached elements should be identified, tagged and stored, preferably on site. Photo: NPS files

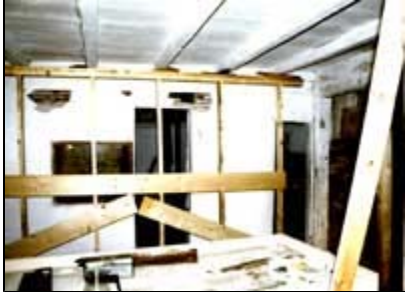
Interior bracing which will last the duration of the mothballing will protect weakened structural members. Photo: John Milner Architects.

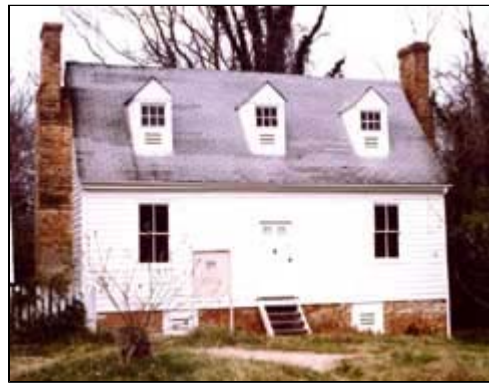
Regrading has protected this masonry foundation wall from excessive damp during its 10-year mothballing. Note the attic and basement vents, temporary stairs, and interpretive sign. Photo: NPS files.

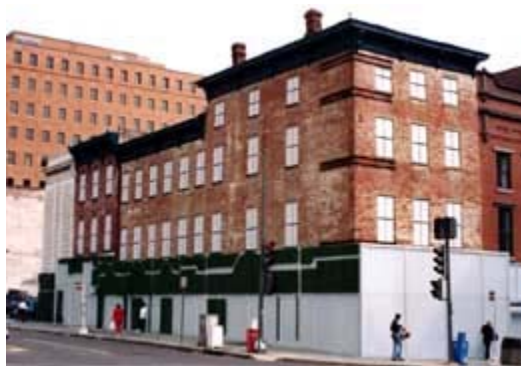
Urban buildings often need additional protection from unwanted entry and graffiti. This commercial building uses painted plywood panels to cover its glass storefronts. The upper windows on the street sides have

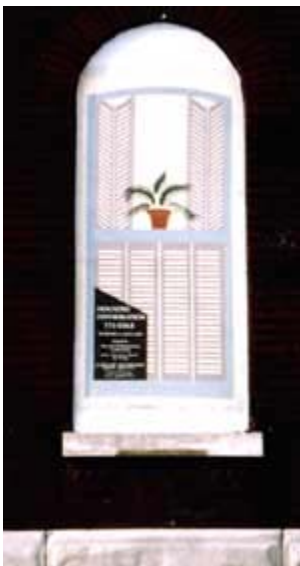
This painted trompe l'oeil scene on plywood panels is a neighborhood-friendly device. Photo: NPS files.

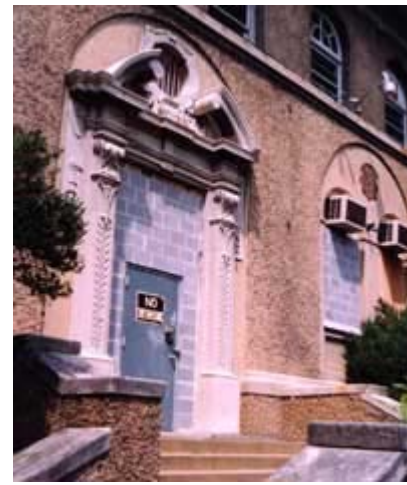
The first floor openings of this historic building have been filled with cinder blocks and the doors, window sash, and frames removed for safe keeping. The security metal door features heavy duty locks. Photo: NPS files.

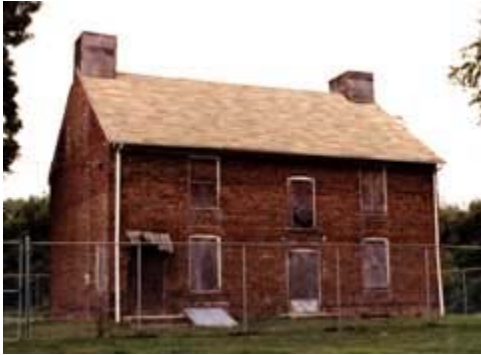
A view showing the exterior of the Brearley House, New Jersey, in its mothballed condition Photo: Michael Mills, Ford Farewell Mills Gatsch, Architects.

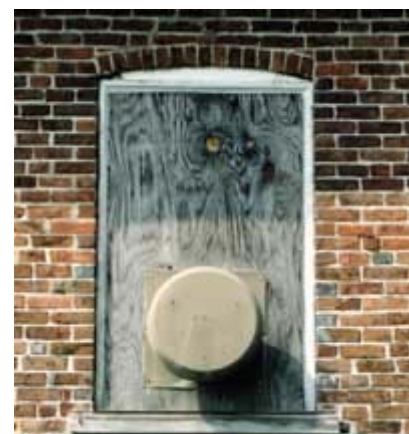
This exhaust fan has tamper-proof housing. Photo: Michael Mills, Ford Farewell Mills Gatsch, Architects.

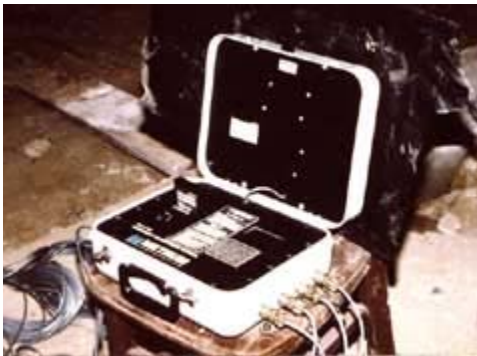
Portable monitors are used to record temperature and humidity conditions in historic buildings during mothballing. Photo: NPS files.
