The Preservation and Repair of Historic Stained and Leaded Glass

Neal A. Vogel and Rolf Achilles

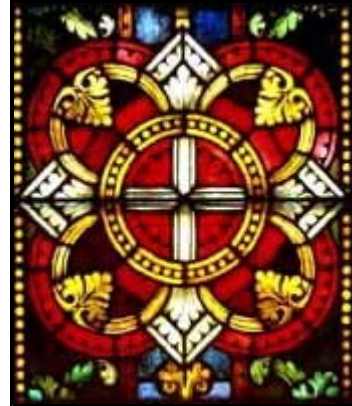
A NOTE TO OUR USERS: The web versions of the **Preservation Briefs** differ somewhat from the printed versions. Many illustrations are new, captions are simplified, illustrations are typically in color rather than black and white, and some complex charts have been omitted.

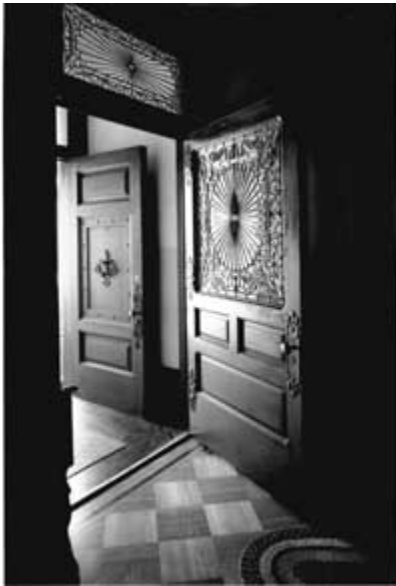
The door and transom of the Edward Hazlett House in Wheeling, West Virginia, (1891-92) suggest the richness of 19th century leaded glass. Photo: Jack E. Boucher, HABS.

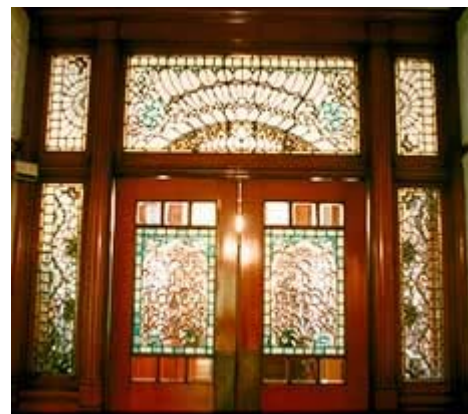
These interior foyer doors deliver dazzling daylight deeper into an 1880s house originally illuminated by gaslight. Photo: Neal A. Vogel.

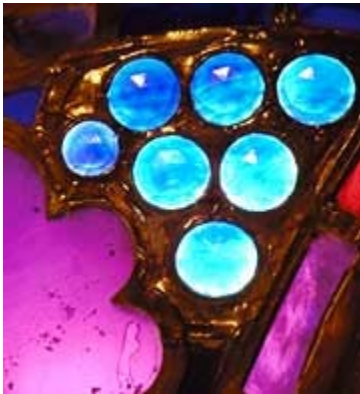
The faceted jewels set in a lead overlay from 1920 were made possible by one of the many glass innovations of the Tiffany Glass & Decorating Company several decades earlier. Photo: Neal A. Vogel.

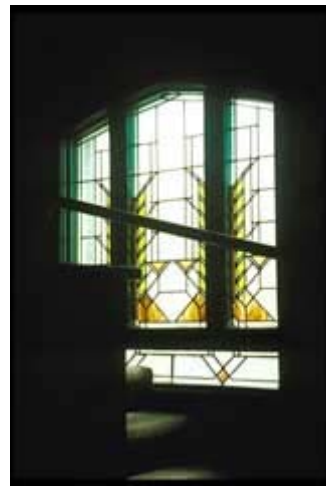
A typical ca. 1910 Prairie School art glass window in Riverside, Illinois, directly influenced by the work of Frank Lloyd Wright. Photo: Neal A. Vogel.

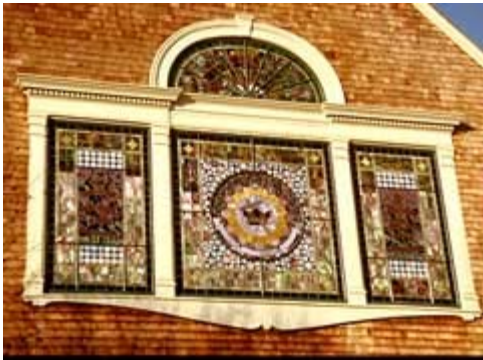
Stained glass is an exterior feature as well as an interior one. As part of any preservation project, it should be photographed from the outside as well as the inside. Photo: Neal A. Vogel.

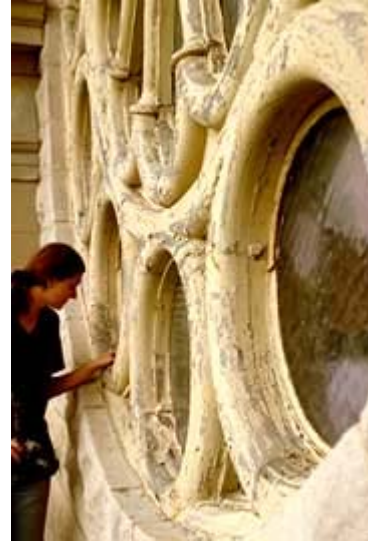
A condition assessment of the frame supporting the stained glass window is as important as evaluating the stained glass itself. Photo: Neal A. Vogel.

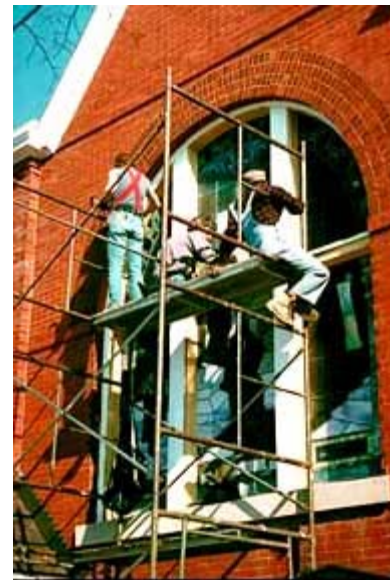
These workmen are performing exterior window maintenance after the protective glazing-- which had prevented maintenance--was removed. Photo: Neal A. Vogel.

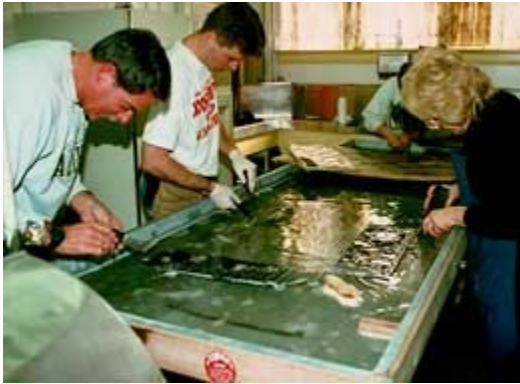
Disassembling leaded glass in warm water helps to soften the putty, minimize breakage, and reduce exposure to airborne dust. Photo: Neal A. Vogel.

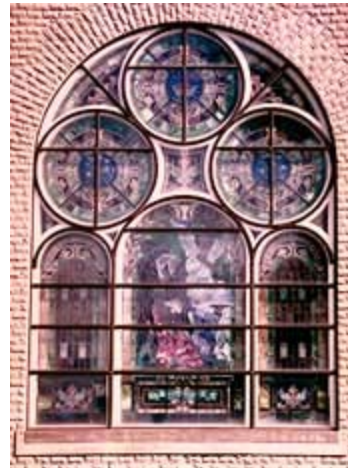
The grid for this protective glazing disregards the configuration of the historic window. The new framing system also causes distracting shadows on the interior. Photo: Neal A. Vogel.

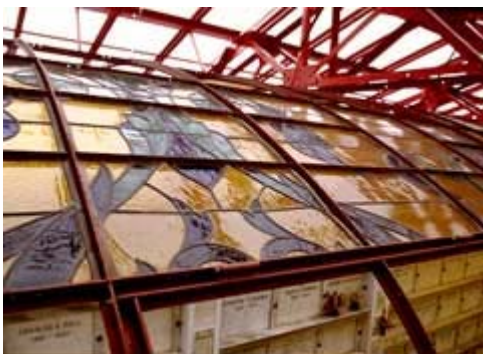
Before repairs began on the vaulted glass ceiling, a new diffusing skylight was installed to correct recurring leaks. Catacombs (ca. 1920), Cypress Lawn Memorial Park, Colma, California. Photo: Neal A. Vogel.
