3 Preservation Briefs

National Park Service
U.S. Department of the Interior

>Conserving Energy in Historic Buildings

Baird M. Smith, AIA

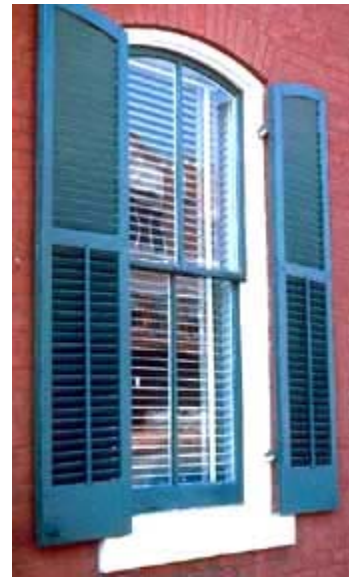
Shutters can be used to minimize the problem of summer heat gain by shading the windows. Photo: NPS files.

Early builders and architects dealt with the poor thermal properties of windows in two ways. First, the number of windows in a building was kept to only those necessary to provide adequate light and ventilation. This differs from the approach in many modern buildings where the percentage of windows in a wall can be nearly 100%. Historic buildings where the ratio of glass to wall is often less than 20%, are better energy conservers than most new buildings. Secondly, to minimize the heat gain or loss from windows, historic buildings often include interior or exterior shutters, interior venetian blinds, curtains and drapes, or exterior awnings. Thus, a historic window could remain an energy efficient component of a building.

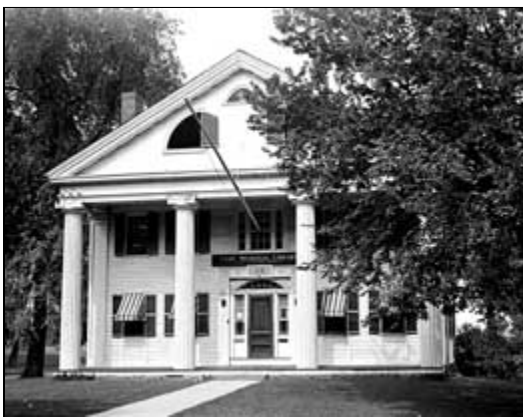
This 19th c. building in Massachusetts employed several energy-conserving features in its historic design, including shade trees, roof overhangs, awnings and shutters. Photo: HABS collection, NPS.

There are other physical characteristics that enable historic buildings to be energy efficient. For instance, in the warmer climates of the United States, buildings were often built to minimize the heat gain from the summer sun. This was accomplished by introducing exterior balconies, porches, wide roof overhangs, awnings and shade trees. In addition, many of these buildings were designed with the living spaces on the second floor to catch breezes and to escape the radiant heat from the earth's surface. Also, exterior walls were often painted light colors to reflect the hot summer sun, resulting in cooler interior living spaces.

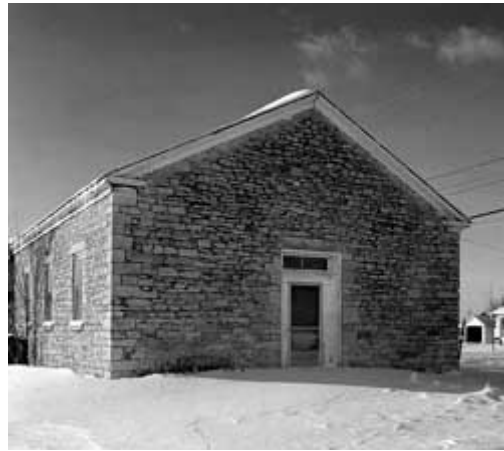
Heavy masonry walls and few windows serve to maximize warmth inside. Photo: HABS collection, NPS.

Winter heat loss from buildings in the northern climates was reduced by using heavy masonry walls, minimizing the number and size of

windows, and often using dark paint colors for the exterior walls. The heavy masonry walls used so typically in the late 19th century and early 20th century, exhibit characteristics that improve their thermal performance beyond that formerly recognized. It has been determined that walls of large mass and weight (thick brick or stone) have the advantage of high thermal inertia, also known as the "M factor." This inertia modifies the thermal resistance (R factor) (1) of the wall by lengthening the time scale of heat transmission. For instance, a wall with high thermal inertia, subjected to solar radiation for an hour, will absorb the heat at its outside surface, but transfer it to the interior over a period as long as 6 hours. Conversely, a wall having the same R factor, but low thermal inertia, will transfer the heat in perhaps 2 hours.

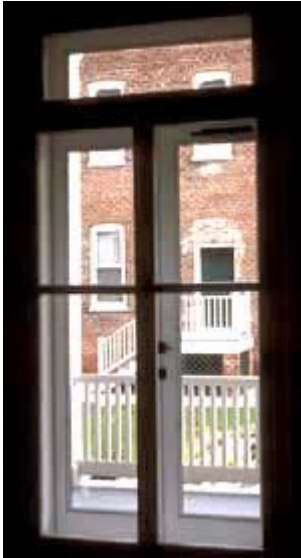
Storm doors have been added on the inside of this historic building as an energy-conserving device. Photo: NPS files.

A storm door would improve the thermal performance of the historic door; however, recent studies indicate that installing a storm door is not normally cost effective in residential settings. The costs are high compared to the anticipated savings. Therefore, storm doors should only be added to buildings in cold climates, and added in such a way to minimize the visual impact on the building's appearance. The storm door design should be compatible with the architectural character of the building and may be painted to match the colors of the historic door.

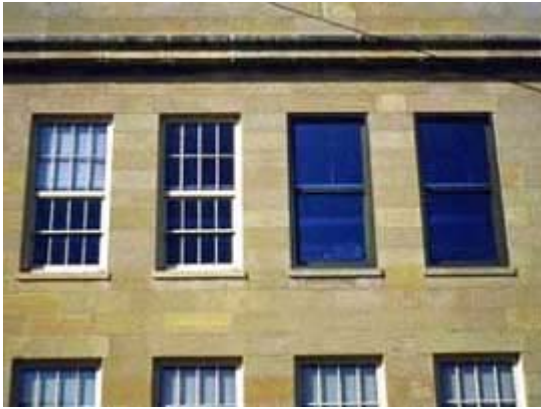
Tinted glazing has jeopardized the character of this historic office building and is, thus, not a recommended approach. Photo: Mike Jackson.

Replacement Windows: Unfortunately, a common weatherization measure, especially in larger buildings, has been the replacement of historic windows with modern double paned windows. The intention was to improve the thermal performance of the existing windows and to reduce longterm maintenance costs. The evidence is clear that adding exterior storm windows is a viable alternative to replacing the historic windows and it is the recommended approach in preservation retrofitting. However, if the historic windows are severely deteriorated and their repair would be impractical, or economically infeasible, then replacement windows may be warranted. The new windows, of either wood or metal, should closely match the historic windows in size, number of panes, muntin shape, frame, color and reflective qualities of the glass.

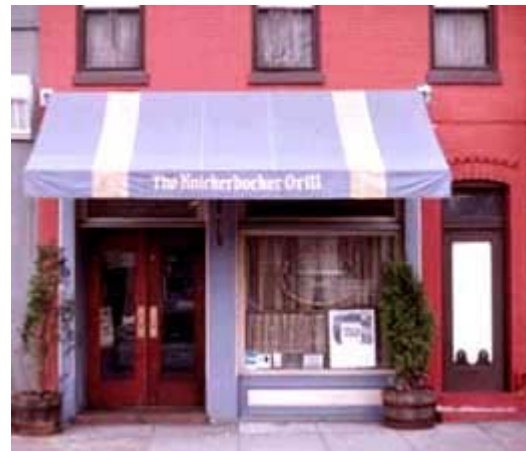
Awnings reduce heat gain in the summer and, when they are raised in the winter, radiant heat from the sun provides free supplementary heat. Photo: NPS files.

Awnings and Shading Devices: In the past, awnings and trees were used extensively to provide shade to keep buildings cooler in the summer. If awnings or trees are in place, keep them in good condition, and take advantage of their energy-saving contribution. Building owners may consider adding awnings or trees if the summer cooling load is substantial. If awnings are added, assure that they are installed without damaging the building or visually impairing its architectural character. If trees are added, select deciduous trees that provide shade in the summer but, after dropping their leaves, would allow the sun to warm the building in the winter. When planting trees, assure that they are no closer than 10 feet to the building to avoid damage to the foundations. Adding either awnings or shade
