## The Maintenance, Repair and Replacement of Historic Cast Stone

Richard Pieper

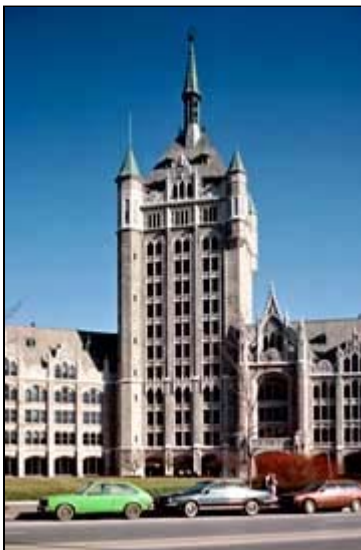
The prominent Delaware and Hudson Building, Albany, New

York, (1916) made extensive use of cast stone as trim combined with a random ashlar facing of natural granite. Photo: Richard Pieper.

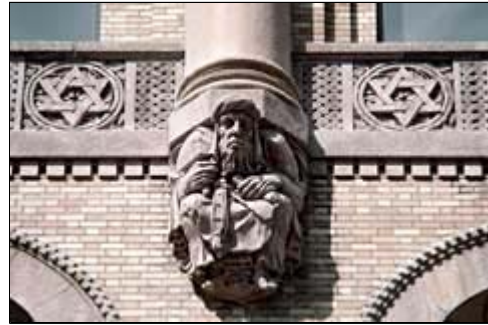
Sculptural ornament was frequently produced in cast stone. Repetitive detail, such as these banding course panels on the Level Club in New York City (1926), were produced much more economically than they could be in natural stone. Photo: Richard Pieper.

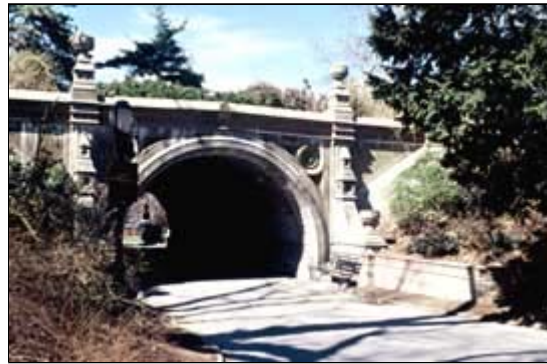
Constructed in 1868 of Beton Coignet, the Cleft Ridge Span in New York City's Prospect Park is one of the earliest extant cast stone structures in the United States. Photo: Richard Pieper.

mix of sand with Rosendale Cement ( a high quality natural cement manufactured in Rosendale, Ulster County, New York). In 1870 Coignet's U.S. patent rights were sold to an American, John C. Goodrich, Jr., who formed the New York and Long Island Coignet Stone Company. This company fabricated the cast stone for one of the earliest extant cast stone structures in the United States, the Cleft Ridge Span in Prospect Park, Brooklyn, New York.

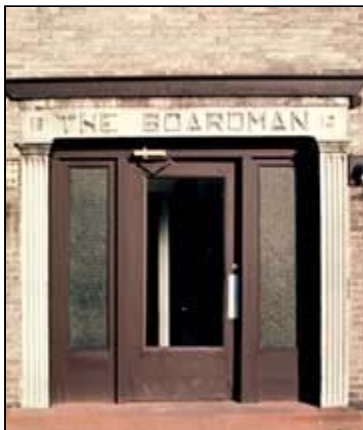
Cast stone was commonly used for molded trim in conjunction with brick or natural stone. This brick building in Rochester, New York, uses cast stone for the entry surround, and natural stone for unornamented windows sills, thresholds, and water table units. Photo: Richard Pieper.

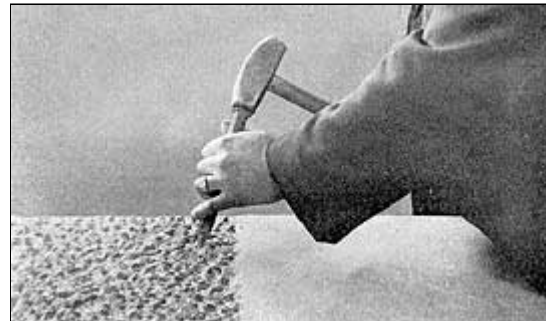
Historically, a point finish was put on with a single pointed chisel. Photo: From Onondaga Litholite Company Catalog. Courtesy, Collection of Michael F. Lynch.

High quality cast stone was frequently "cut" or tooled with pneumatic chisels and hammers similar to those used to cut natural stone. In some cases, rows of small masonry blades were used to create shallow parallel grooves similar to lineal chisel marks. The results were often strikingly similar in appearance to natural stone. Machine and hand tooling was expensive, however, and simple molded cut cast stone was sometimes only slightly less costly than similar work in limestone. Significant savings could be achieved over the cost of natural stone when repetitive units of ornate carved trim were required.

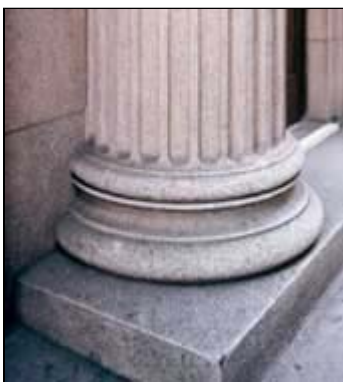
For this column, the appearance of a "pink granite" was simulated by using a pinkish matrix with white and black aggregate. Erosion of a tinted matrix results in a significant lightening of the cast stone surface. Photo: Richard

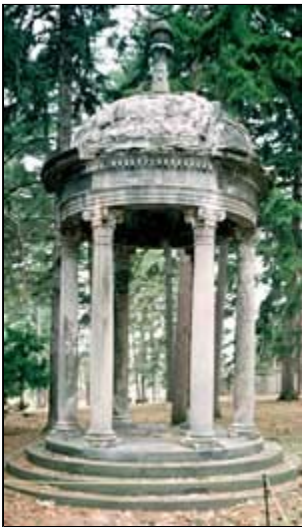
Scaling of cast stone units signals problems with the cementing mix and method of manufacture. Serious deterioration of cast stone, such as this, warrants replacement. Photos: Richard Pieper.

While it is relatively uncommon in twentieth century cast stone, serious deterioration of the cementing matrix can cause extensive damage to cast stone units. A properly prepared cementing mix will be durable in most exterior applications, and any flaking of exterior surfaces signals problems in the cementing mix and in the method of manufacture. The use of poor quality or improperly stored cement, impure water, or set accelerators can cause cement problems to occur years after a structure is completed. Improper mixing and compaction can also result in a porous concrete that is susceptible to frost damage and scaling. Severe cement matrix problems may be impossible to repair properly and often necessitate replacement of the deteriorating cast stone units.

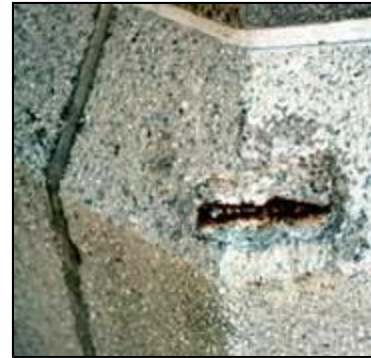
Rusting of reinforcement near the surface of the stone may result in spalling. Sections of reinforcement, such as this, may be cut out and the spall repaired with a matching composite mortar. Photo: Richard Pieper.

To repair a spall caused by deterioration of a ferrous reinforcement bar or anchorage, it is necessary to remove all cracked concrete adjacent to the spall; grind and brush the reinforcement to remove all rust and scale; and paint the metal with a rust-inhibiting primer prior to applying the cast stone composite. If the reinforcement bar is much too close to the surface of the stone, it may be advisable to cut out the deteriorating section of reinforcement after consultation with a structural engineer. If deteriorating cramps are removed, it may be necessary to install new stainless steel anchorage.

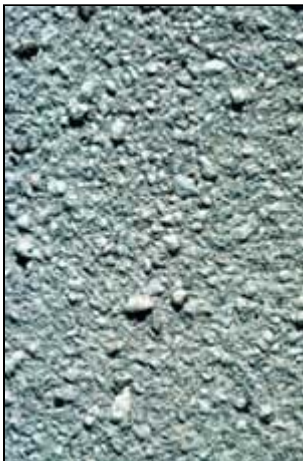
Sandblasting and wet grit blasting can seriously erode the surface and should not be used to clean cast stone surfaces.

In either case, dark particulate staining in protected areas may be persistent, however, and require experimentation with other cleaning methods. Some micro-abrasive cleaning techniques used under very controlled circumstances by skilled cleaning personnel can be appropriate for removing tenacious soiling. Ordinary sand blasting or wet grit blasting can seriously damage the surface of the cast stone and should not be used.

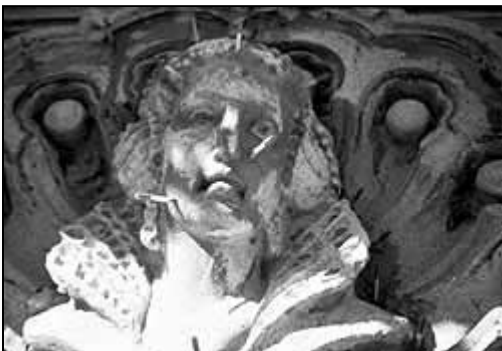
**A delaminated layer of ornamental cast stone on the Orpheum Theater, San Francisco, California (1925), was successfully re-attached using epoxy. The multiple delivery ports for the epoxy are removed after treatment and the holes**

patched. Photo: David P. Wessell.

Where the decorative facing of dry tamped cast stone has separated from core layers, injected grouts may be used to re-secure the facing. Re-attachment of a separated facing layer may be time consuming, and should be undertaken by a conservator, rather than a mason. This technique may be the best, most economical, approach for repair of figurative sculpture or unique elements that are not repeated elsewhere on a building. Theoretically, cementitious grouts are most appropriate for re-attaching separated facings, but hairline fissures may require the use of resin adhesives. Low-viscosity epoxies have been used for this purpose, and may be applied through

small injection ports. Cracks that would allow adhesive to leak must be repaired prior to injection, of course. Holes made for adhesive injection will require patching after re-attachment is complete.

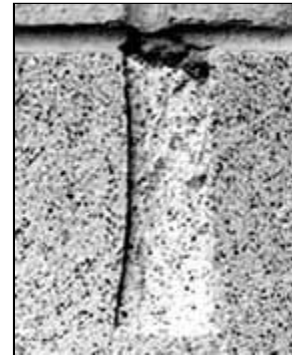
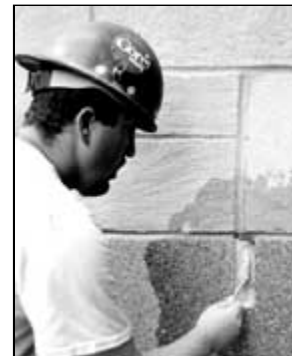
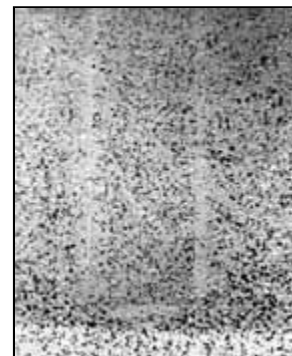
(top) The damaged area is cut out to create a shallow void of even depth, 1/2" or more. (middle) The composite mortar is applied to the void with a small spatula or trowel. (bottom) This completed composite repair could have been

improved by brushing to remove the matrix residue at the edges of the repair before the surface cured. Photos: Richard Pieper.

Where spalls have a feather edge, it will be necessary to cut back the repair area to a uniform depth (1/2" or more). As with natural stone composite repairs, a bonding agent may assist adhesion of the repair material to the original concrete. For unusually large or deep patches, mechanical anchoring of the repair with small nylon or stainless steel rods may be required.

If the adjacent cast stone is tooled or weathered, it will be necessary to scribe or brush the repaired area to give it a matching surface texture. Adding enough coarse aggregate to match adjacent original material will sometimes interfere with adhesion of the composite, and it may be necessary to press additional aggregate into the applied patch prior to finishing. If this is not skillfully done, however, the surface of the patch may take on a mosaic appearance. For this reason, it is advisable to undertake test composite repairs in an unobtrusive location first.

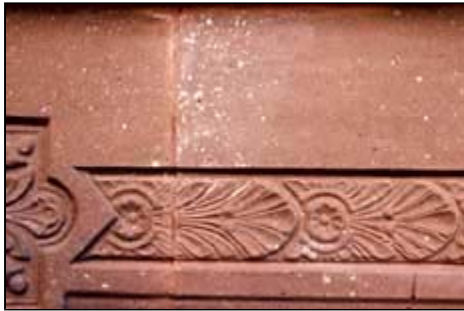
Unlike natural stone, cast stone generally may not be tooled in place to reduce lippage of uneven surfaces at joints. Tooling often exposes coarse aggregate from below the surface. Photo: Richard Pieper.

Tooling or grinding of the surface of the cast stone may expose coarse aggregate beneath the surface and will not, in any case, restore original patterned pigmentation that has weathered away. Silicate paints or masonry stains may be applied in patterns to replicate the original appearance, but may not be durable or completely successful aesthetically. Where matrix has eroded, it is advisable to accept the weathered appearance of the cast stone, unless extensive replacement is mandated by other factors.

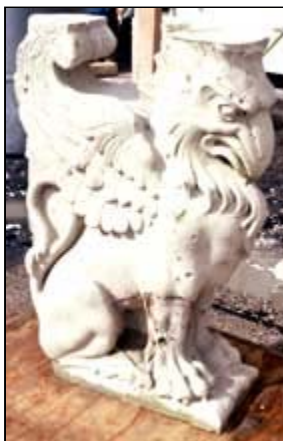
After removal from the

mold, the new cast stone units are scrubbed to remove surface paste and expose underlying aggregate. End cast pieces, such as this sculpture, may have numerous air bubbles at the surface. Photo: Richard Pieper.

**Air bubbles.** Small pits on the surface of the stone may form if the unit is not given adequate vibration to release trapped air during pouring. Bubbles can also be a problem when end casting long items such as columns or railings, where it is difficult to vibrate bubbles away from the finish surface of the unit.

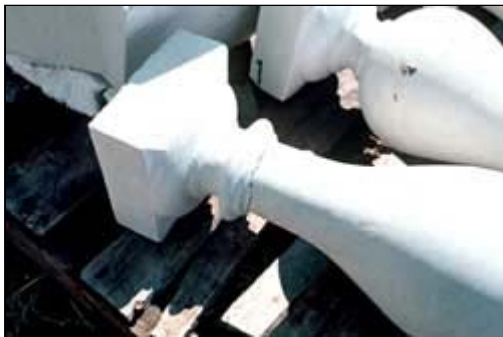
Surface cracking may reduce the durability of cast stone units. Cracking is often problematic on reinforced elements with thin "necks," such as balusters, unless curing is carefully controlled. Photo: Richard Pieper.

**Surface cracking or checking.** Overly wet mixes and insufficient moisture during curing can result in surface cracking of large castings, such as columns. Such cracking dramatically reduces the durability of new cast stone. Small reinforced elements, such as balusters, also frequently crack at thin "necks" in the castings.

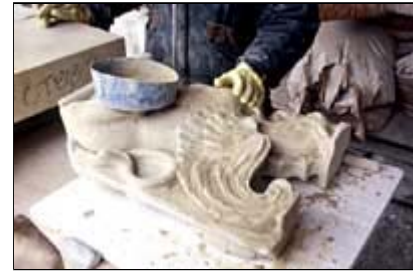
The holes on the surface of the casting (see above, left) are being filled with a mortar similar to the concrete mix used to cast the element. Photo: Richard Pieper.

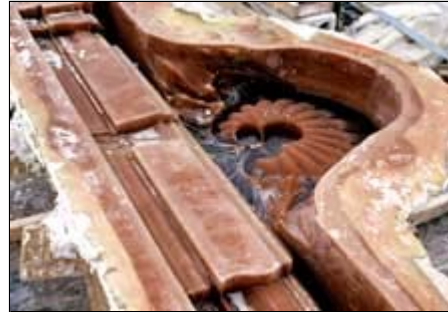
Production molds made of durable rubbers backed with wood and plaster supports are used to fabricate new cast stone. Photo: Richard Pieper.

**Surface rippling or irregularity.** Production molds for fabrication are often made of rubber mold facings encased in larger "mother molds" of plaster and wood. Vibration can loosen the rubber facing from the outer mold and result in rippling or irregularities on the surface of the finished casting. Even when rippling is not noticeable, irregularity caused by mold movement can make it difficult to line up surfaces of adjacent units when assembling cast stone installations.

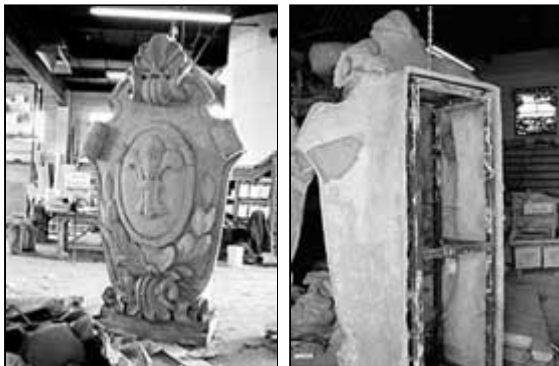
GFRC is sometimes used to replicate deteriorated elements of cast or fine grained natural stone. Because the GFRC element is a rigid, but relatively thin shell, it must be supported and attached with an interior

framework of steel. The attachment hardware inside this GFRC cartouche (left) will not be visible when the unit is installed (armature visible at right). Photos: Towne House Restorations, Inc.

Glass fiber reinforced concrete (GFRC) is more and more frequently encountered in building restoration and is used to replicate deteriorated stone and cast stone, and even architectural terra cotta. This is a relatively new material that uses short chopped strands of glass fiber to reinforce a matrix of sand and cement. GFRC has become a popular low cost alternative to traditional precast concrete or stone masonry for some applications. Fabricators use a spray gun to spray the mortar-like mix into a mold of the shape desired. The resulting concrete unit, typically only  $\frac{3}{4}$ " thick, is quite rigid, but requires a metal frame or armature to secure it to the building substrate. The metal frame is joined to the GFRC unit with small "bonding pads" of GFRC.
