44 Preservation Briefs

The Use of Awnings on Historic Buildings Repair, Replacement & New Design

Chad Randl

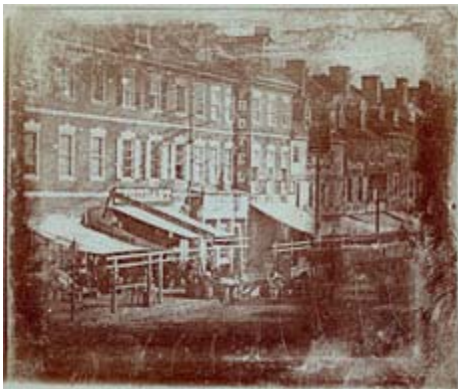
Early 19th century awnings featured canvas coverings stretched between the building facade and post-supported front bars. Projecting frameworks of extension bars were not common until later in the century. Photo: Second Street, Philadelphia, c. 1841, Print and Photo Collection, The Free Library of Philadelphia.

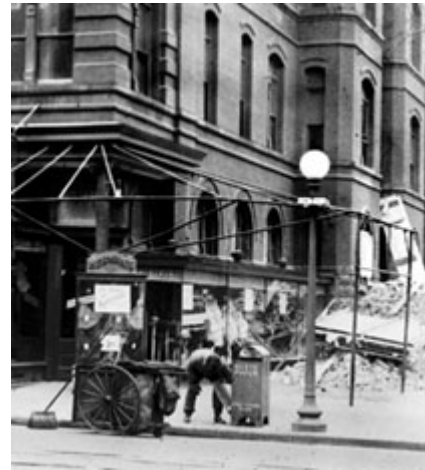
During the second half of the 19th century, iron plumbing pipe became a popular material for fixed awning frames. Here, a pipe frame without its canvas cover extends around the corner of a building in Washington, D.C. Photo: Library of Congress, Prints and Photographic Division, LC-USZ62-121160.

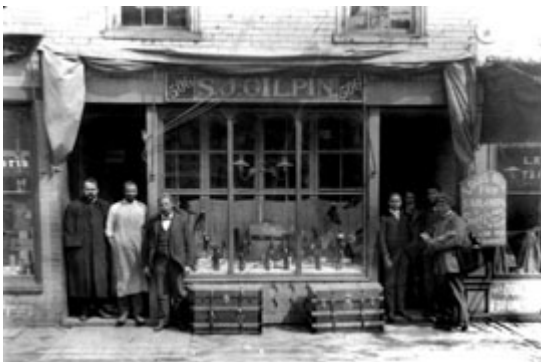
A 19th century shoe store in Richmond, Virginia had an operable awning retracted against the building facade. Hinged extension arms were raised and lowered allowing for an awning configuration easily changed in response to weather conditions. This photo shows how the fabric gathered and was exposed to the elements when retracted - part of the reason roller awnings later became prevalent. Photo: Library of Congress, Prints and Photographic Division, LC-USZ62-99053.

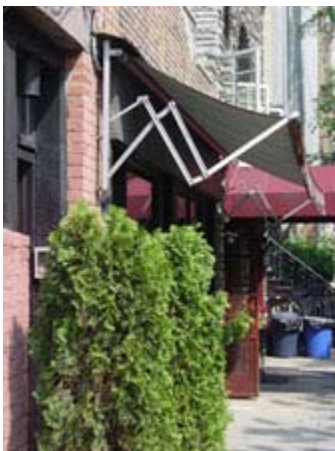
Scissor arm awnings have a pair of vertical, hinged arms on either side of the assembly supporting the front bar. To unfurl the awning, the roller is cranked and the arms extend outward

pulling the cover away from the roller. Photo: NPS files.

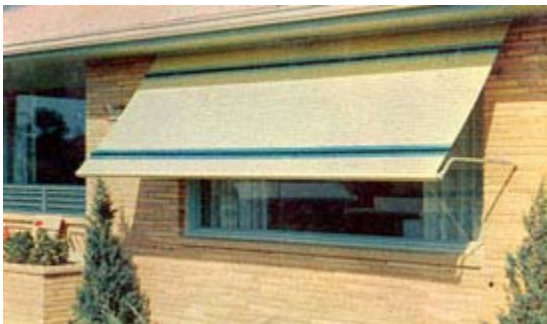
The years after World War II saw the widespread adoption of aluminum awnings on

both storefronts and residences. Operable aluminum awnings incorporated a spring-loaded roller into the frontbar. Photo: NPS files.

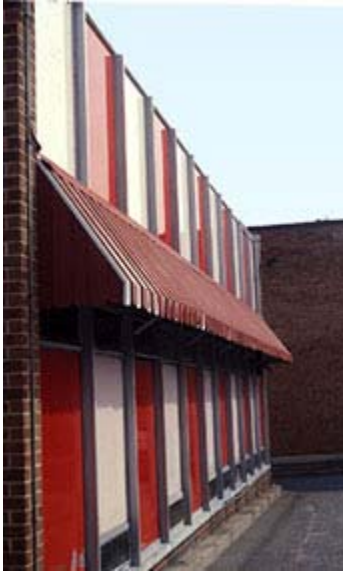
This 1950s-era dry cleaner has an aluminum awning that, with its vertical pattern and alternating stripes, complements the facade's porcelain enamel panels and aluminum mullions. The awning forms an essential element of the building's historic character. Photo: NPS files.

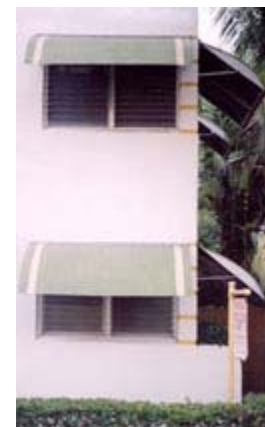
These fiberglass "clamshell" awnings, although not as old as the 1930s building to which they were affixed, are important features that have acquired significance. They were retained when the building was recently rehabilitated. Photo:

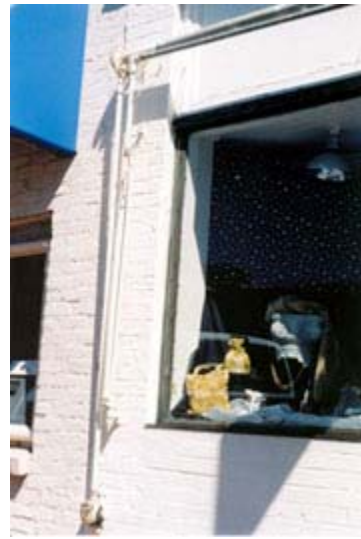
A gearbox, slide rod, roller, front bar, and extension arm reveal that this 19th century facade once featured a retractable awning. It is likely that with minor repairs the surviving hardware could again be made operable, recovered with a canvas or acrylic fabric, and reused to service the storefront. Photo: NPS files.

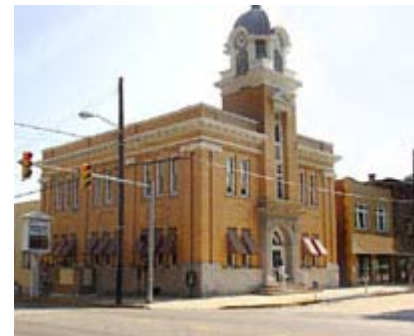
Using the historic photos as a guide (see photo, above, left), new awnings with a similar shape and stripe pattern were installed increasing the comfort of employees and protecting county records from direct sunlight. Photo: NPS files.

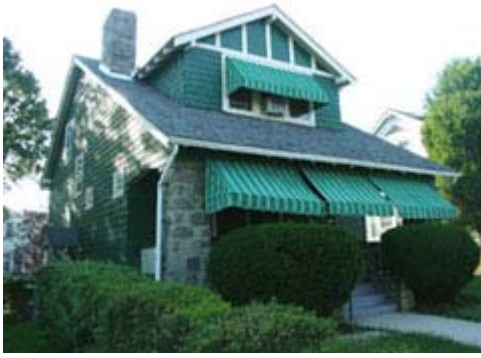
Simple shed-type awnings with acrylic or canvas coverings and free-hanging valances are appropriate for most historic residences featuring rectilinear openings. Photo: NPS files.

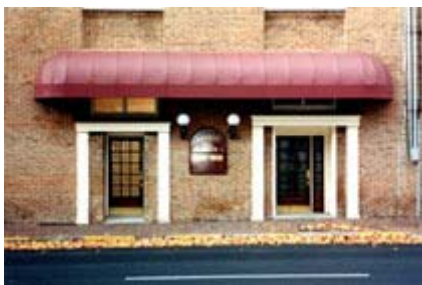
Single awnings should not be set over more than one door or window bay. A separate shed awning with a canvas or acrylic covering would be more appropriate over each of these openings. Photo: NPS files.

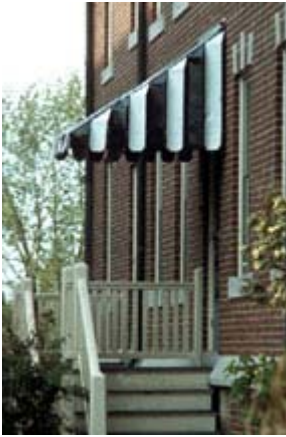
This postwar aluminum awning does not contribute to the character of this 19th century residence and could be replaced during a rehabilitation project with a fabric shed awning more in keeping with the building's age and appearance. Photo: NPS files.

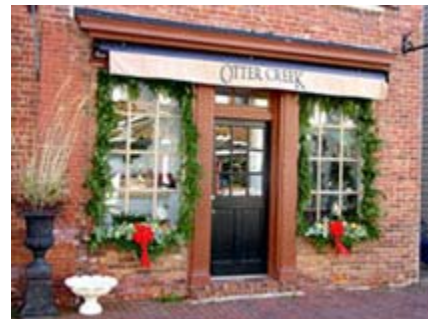
Appropriate lettering, as on this roller awning valance, can function as distinctive signage without detracting from the historic character of the building. Photo: NPS files.

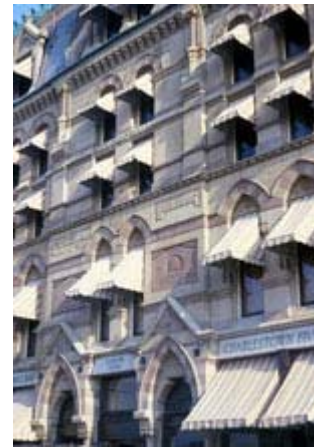
These window awnings today match what would have appeared in the 19th century. The fabric is slightly loose on the frames, the valances hang freely, each window bay has its own awning, and the awning frames are set within the openings. Photo: Mike Jackson.
