4 Preservation Briefs

National Park Service
U.S. Department of the Interior

>Roofing for Historic Buildings

Sarah M. Sweetser

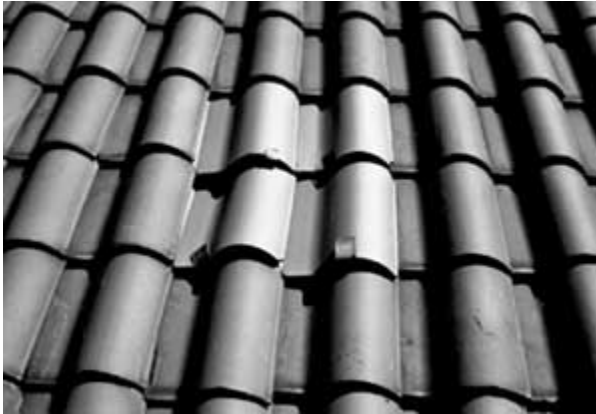
Repairs on this pantile roof were made with new tiles held in place with metal hangers. Photo: NPS files.

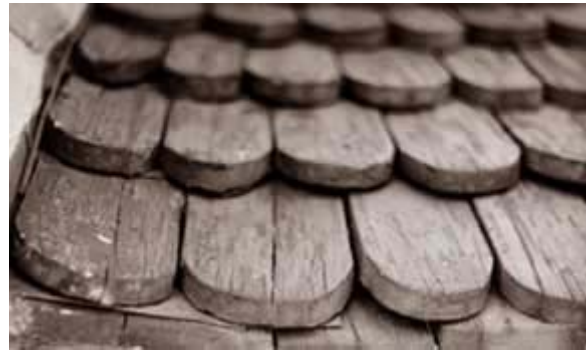
Replacement of particular historic details is important to the individual historic character of a roof, such as this rounded butt wood shingle roof. In the restoration, the drainage around a dormer was improved by the addition of carefully concealed modern metal flashing. Photo: NPS files.

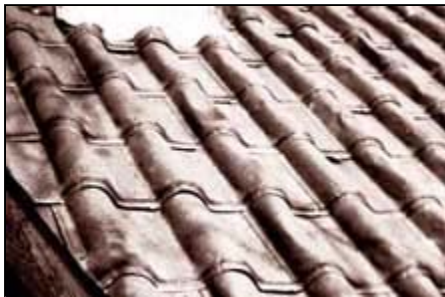
Galvanized sheet-metal shingles imitating the appearance of pantiles remained popular from the second half of the 19th century into the 20th century. Photo: NPS files.

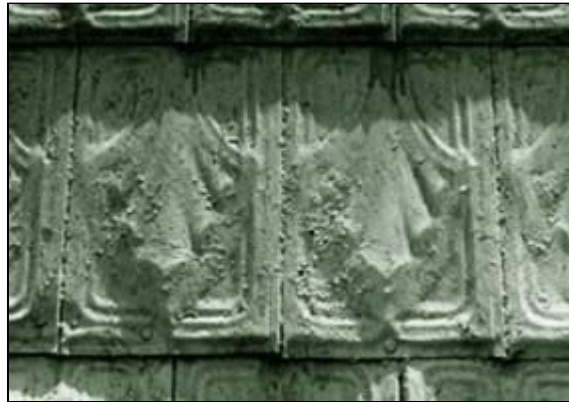
Tin shingles, commonly embossed to imitate wood or tile, or with a decorative design, were popular as an inexpensive, textured roofing material. Photo: NPS files.

However, once rolling mills were established in this country, the low cost, light weight, and low maintenance of tin plate made it the most common roofing material. Embossed tin shingles, whose surfaces created interesting patterns, were popular throughout the country in the late 19th century. Tin roofs were kept well-painted, usually red; or, as the architect A. J. Davis suggested, in a color to imitate the green patina of copper.

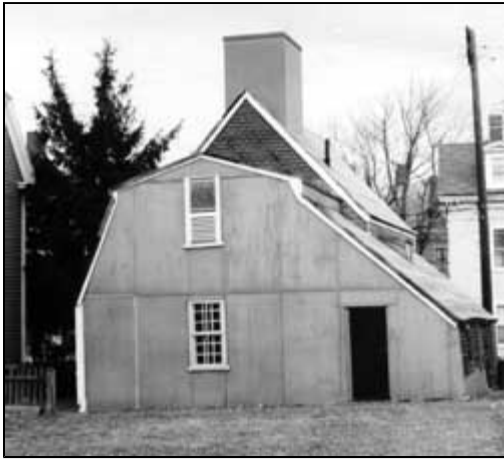
Temporary stabilization or "mothballing" with materials, such as plywood and building paper, can protect the roof of a project until it can be properly repaired or replaced. Photo: NPS files.

It may be necessary to carry out an immediate and temporary stabilization to prevent further deterioration until research can determine how the roof should be restored or rehabilitated, or until funding can be provided to do a proper job. A simple covering of exterior plywood or roll roofing might provide adequate protection, but any temporary covering should be applied with caution. One should be careful not to overload the roof structure, or to damage or destroy historic evidence or fabric that might be incorporated into a new roof at a later date. In this sense, repairs with caulking or bituminous patching compounds should be recognized as potentially harmful, since they are difficult to remove, and at their best, are very temporary.

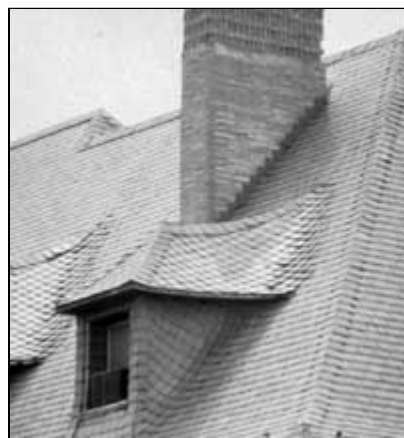
Because of the roof's visibility, the slate detailing around the dormers is important to the character of this structure. Photo: NPS files.

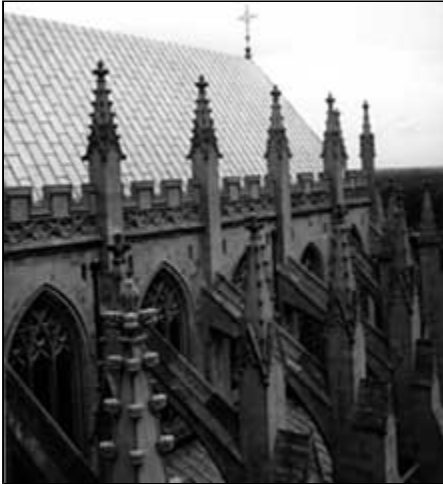
Good design and quality materials for the roof surface, fastenings, and flashing minimize failures. Photo: NPS files.

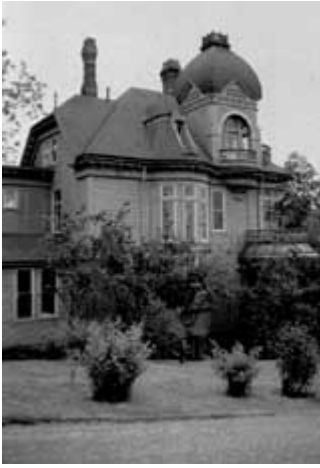
Special problems inherent in the design of an elaborate historic roof can be controlled through regular maintenance. The shape and detailing are essential elements of the building's historic character, and should not be modified, despite the use of alternative surface materials. Photo: NPS files.
