# 5 Preservation Briefs

National Park Service  
U.S. Department of the Interior

## Preservation of Historic Adobe Buildings

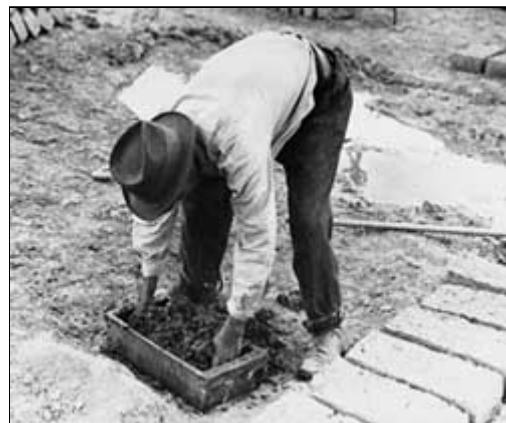
A mixture of mud and straw is pressed into a mold to form an adobe brick. After the adobe brick is removed from the mold, it must dry in the open air for a month or more before it can be used. Photo: Russell

**The Brick:** The adobe brick is molded from sand and clay mixed with water to a plastic consistency. Commonly, straw or grass is included as a binder. Although they do not help reinforce the bricks or give them added long-term strength, straw and grass do help the bricks shrink more uniformly while they dry. More important for durability, however, is the inherent clay-to-sand ratio found in native soil. The prepared mud is placed in wooden forms, tamped, and leveled by hand. The bricks are then "turned-out" of the mold to dry on a level surface covered with straw or grass so that the bricks will not stick. After several days of drying, the adobe bricks are ready for air-curing. This consists of standing the bricks on end for a period of 4 weeks or longer.

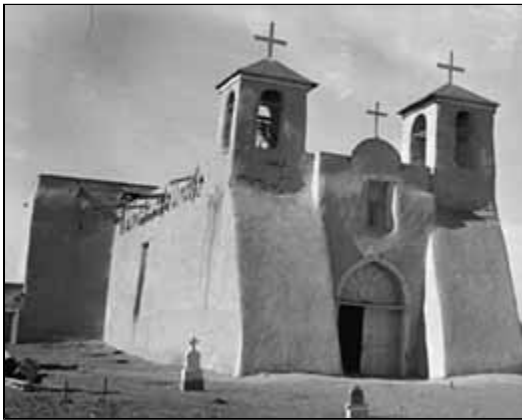
San Francisco de Assisi Mission Church in Rancho de Taos, NM, was constructed of adobe between 1772 and 1819 and, because of its distinctive sculptural quality, is one of the most famous and frequently photographed of the mission churches. Photo: HABS Collection, NPS.

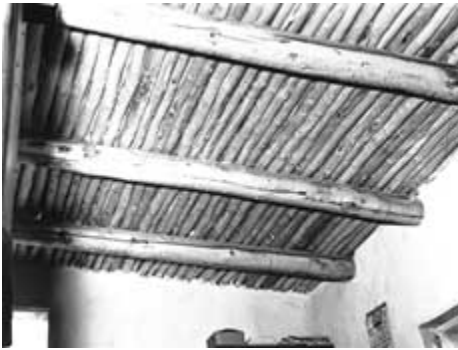
Viga logs and savinos are seen in the interior of the adobe building. Often the wooden materials that comprise the traditional flat adobe roof create interesting and pleasing patterns on the ceilings of interior rooms. Photo: Russell Lee, Farm Security Administration Collection, Library of Congress.

lathing or layers of twigs covered with packed adobe earth. The wood was aspen, mesquite, cedar, or whatever was available. Roughly dressed logs (called "vigas") or shaped squared timbers were spaced on close (23 feet or less) centers resting either on the horizontal wooden member which topped the adobe wall, or on decorated cantilevered blocks, called "corbels," which were set into the adobe wall. Traditionally, these vigas often projected through the wall facades creating the typical adobe construction detail copied in the 20th century revival styles. Wooden poles about 2 inches in diameter (called "latias") were then laid across the top of the vigas. Handsplit planks (called "cedros" if cedar and "savinos" if cypress) instead of poles were used when available. In some areas, these were laid in a herringbone pattern. In the west Texas and Tucson areas, "saguaro" (cactus) ribs were used to span between vigas. After railroad transportation arrived in most areas, sawn boards and planks, much like roof sheathing, became available and was often used in late-19th and early-20th century buildings or for repairs to earlier ones.

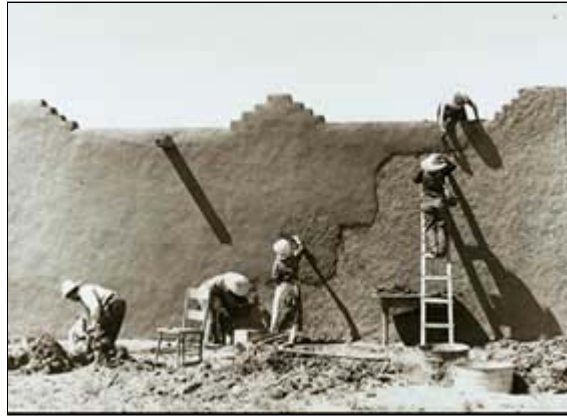
Traditionally, adobe surface coatings that protected the fragile adobe building fabric were renewed every few years. Women are seen here recoating an adobe wall with mud plaster mixed with straw at Chamisal, New Mexico. Photo: Russell Lee, Farm Security Administration Collection, Library of Congress.

**Mud Plaster:** Mud plaster has long been used as a surface coating. Like adobe, mud plaster is composed of clay, sand, water, and straw or grass, and therefore exhibits sympathetic properties to those of the original adobe. The mud plaster bonds to the adobe because the two are made of the same materials. Although applying mud plaster requires little skill, it is a time-consuming and laborious process. Once in place, the mud plaster must be smoothed. This is done by hand; sometimes deerskins, sheepskins, and small, slightly rounded stones are used to smooth the plaster to create a "polished" surface. In some areas, pink or ochre pigments are mixed into the final layer and "polished."

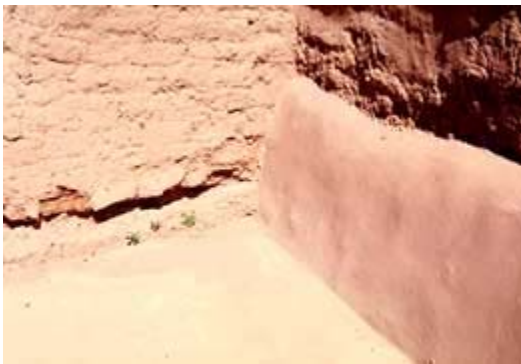
Coving at the base of this adobe wall may have been caused by salts deposited by rising groundwater and/or rainwater splash. Photo: NPS files.

The erosive action of rainwater and the subsequent drying out of adobe roofs, parapet walls, and wall surfaces can cause furrows, cracks, deep fissures, and pitted surfaces to form. Rain saturated adobe loses its cohesive strength and sloughs off forming rounded corners and parapets. If left unattended, rainwater damage can eventually destroy adobe walls and roofs, causing their continued deterioration and ultimate collapse. Standing rainwater that accumulates at foundation level and rain splash may cause "coving" (the hollowing-out of the wall just above grade level).

In repairing "coving," the damage caused by rain splash, adobe bricks stabilized with soil cement might be considered. On the other hand, concrete patches, cement stucco, and curb-like buttresses against the coving usually have a negative effect because moisture may be attracted and trapped behind the concrete.

Once any one or all of these solutions has effectively minimized the problems of rising ground water, the coving and deterioration of the walls can be corrected by patching the area with new adobe mud and by applying traditional surface coatings. It should be remembered, however, that unless the capillary action is stopped effectively, this erosive condition will certainly continue. Most important, surface coatings and patching only repair the effects of ground water and wind erosion, they cannot cure the cause.

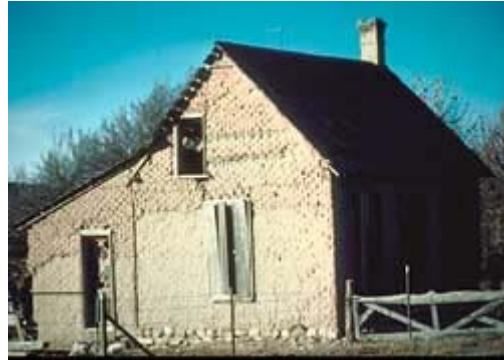
A traditional mixture of mud and straw plaster should be applied to stabilize the exterior of this house. Photo: NPS files.

When the coating has been mud plaster, the process requires that the deteriorated mud plaster be scraped off and replaced with like materials and similar techniques, attempting in all cases to match the repair work as closely as possible to the original. It is always better to cover adobe with mud plaster even though the mud plaster must be renewed more frequently.
