## Aluminum and Vinyl Siding on Historic Buildings on Historic Buildings The Appropriateness of Substitute Materials for Resurfacing Historic Wood Frame Buildings

John H. Myers, revised by Gary L. Hume

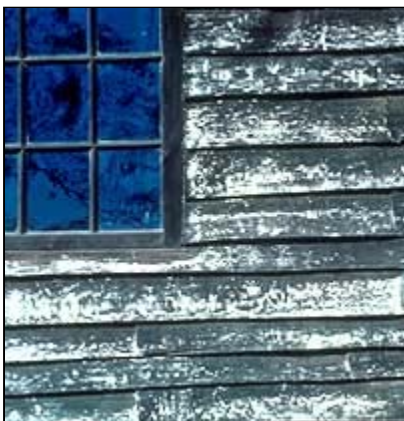
Historic wood siding exhibits rich and varied surface textures. They range from hand-split clapboards of short lengths with feather-edged ends (shown here), to pit or mill sawn boards which can be beveled, rabbeted, or beaded. Photo: NPS files.

The variety of tools used, coupled with regional differences in design and craftsmanship, has resulted in a richness and diversity of wood sidings in America. For example, narrow boards with beveled, lapped joints called "clapboards" were used on New England frame dwellings. The size and shape of the "clapboards" were determined by the process of hand splitting or "riving" bolts of wood. The width, the short lengths, the beveled lapping, the "feathered" horizontal joints, and the surface nailing of the clapboards created a distinctive surface pattern that is recognizable as an important part of the historic character of these structures.

The sawn and hand-planed clapboards used throughout the Mid-Atlantic and Southern states in the eighteenth and early nineteenth centuries, by contrast, have a wide exposure--generally between six and eight inches. The exposure of the siding, frequently coupled with a beaded edge, created a very different play of light and shadow on the wall surface, thus resulting in a different character. The "German" or "Novelty siding"--a milled siding that is thin above and thicker below with a concave bevel--was used throughout many parts of the United States in the late nineteenth and early twentieth century but with regional variations in material, profile, and dimensions. One variation of this type of milled siding was called "California siding" and was milled with a rabbetted or shiplap edge to insure a tight installation of the weather boards. Shingles were also commonly used as an exterior cladding material, and in buildings such as the Bungalow style houses, were often an important character-defining feature of the exterior. Shingles were often applied in decorative patterns by varying the lap, thus creating alternating rows of narrow exposures and wide exposures. Shingles were also cut in geometric patterns such as diamond shapes and applied in patterns. This treatment was commonly used in the gable end of shingled houses. Siding and wood shingles were often used in combination with materials such as cobblestone and brick in Bungalow style buildings to create a distinctive interplay of surfaces and materials.

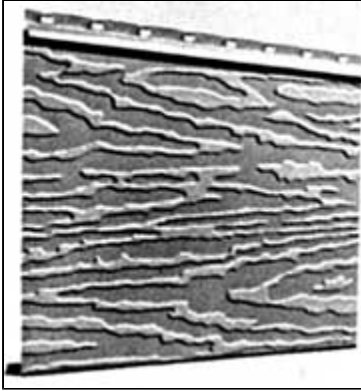
**Aluminum and vinyl siding are available in a variety of widths and colors, but the optional wood graining is not characteristic of real wood siding. Photo: NPS files.**

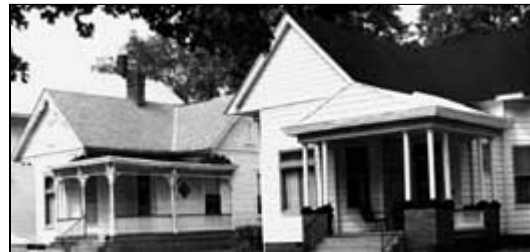
**When aluminum was installed on the house on the right, the barge boards, scrollwork, columns, and railings were removed. The distinctive shingled gable and attic vent were covered, further compromising the building's architectural integrity. Photo: NPS files.**

Although it is sometimes argued that an artificial siding application is reversible since it can be removed, there is frequently irreversible damage to historic building materials if decorative features or trim are permitted to be cut down or destroyed, or removed by applicators and discarded. The installation process requires that the existing surface be flat and free of "obstructions" so that the new siding will be smooth and even in appearance. To achieve the requisite flat surface, furring strips are usually placed over the wall surface (vertical furring strips for horizontal aluminum or vinyl siding and vice-versa for vertical siding). The potential danger in this type of surface

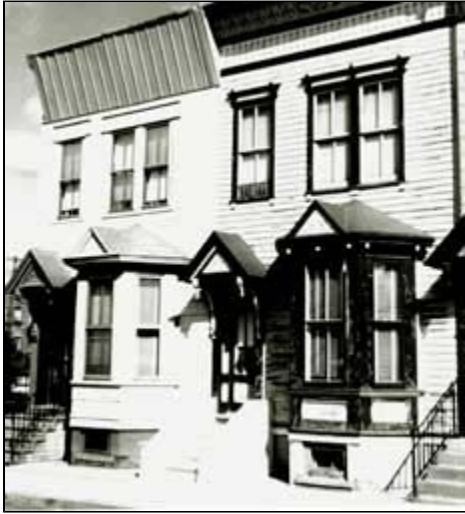
When a building is in need of maintenance, such as the house on the right which needs painting, some owners consider installing aluminum or vinyl siding. The result (see left) can be a complete loss of architectural character due to the covering of details and change of scale due to inappropriate siding dimensions. Photo: NPS files.

preparation is that the furring strips may change the relationship between the plane of the wall and the projecting elements such as windows, door trim, the cornice, or any other projecting trim or molding. Projecting details may also cause a problem. To retain them, additional cutting and fitting will usually be required. Further, additional or special molding pieces, or "accessories" as they are called by the industry, such as channels, inserts and drip caps, will be needed to fit the siding around the architectural features. This custom fitting of the siding will be more labor-intensive, adding to the cost of the siding installation.

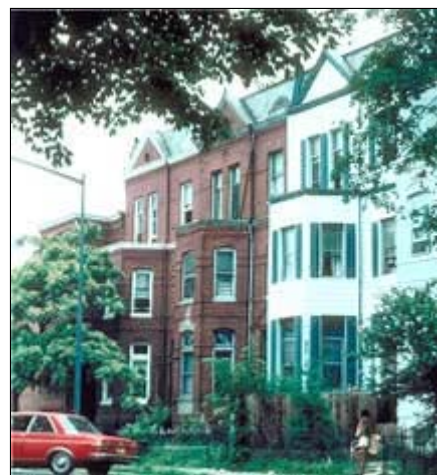
The inappropriate siding applied to the house on the right has altered the character of the urban setting. Photo: NPS files.
