The Repair of Historic Wooden Windows

John H. Myers

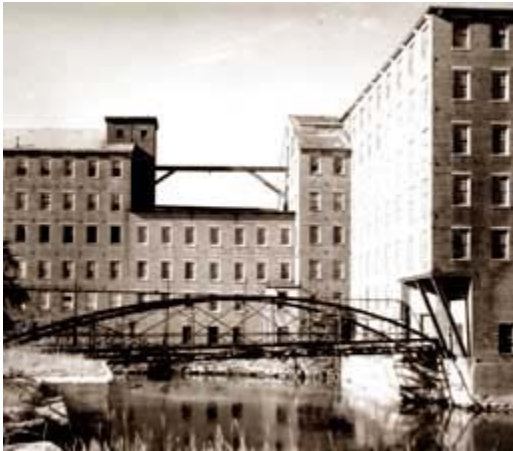
Windows are frequently important visual focal points, especially on simple facades such as this mill building. Replacement of the multi-pane windows with larger panes could dramatically alter the appearance of the building. Photo: NPS files.

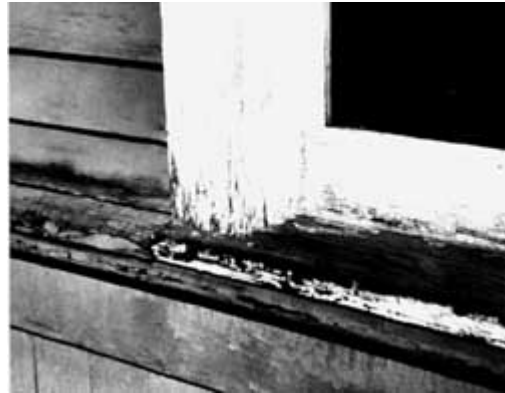
Deterioration of poorly maintained windows usually begins on horizontal surfaces and at joints, where water can collect and saturate the wood. Photo: NPS files.

Each window should be examined for operational soundness beginning with the lower portions of the frame and sash. Exterior rainwater and interior condensation can flow downward along the window, entering and collecting at points where the flow is blocked. The sill, joints between the sill and jamb, corners of the bottom rails and muntin joints are typical points where water collects and deterioration begins. The operation of the window (continuous opening and closing over the years and seasonal temperature changes) weakens the joints, causing movement and slight separation. This process makes the joints more vulnerable to water which is readily absorbed into the endgrain of the wood. If severe deterioration exists in these areas, it will usually be apparent on visual inspection, but other less severely deteriorated areas of the wood may be tested by two traditional methods using a small ice pick.

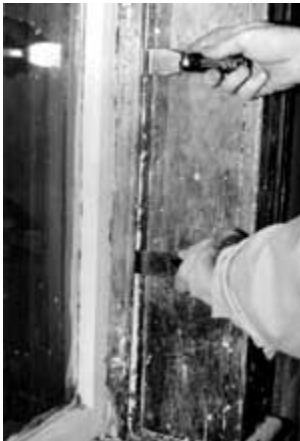
After removing paint from the seam between the interior stop and the jamb, the stop can be pried out and gradually worked loose using a pair of putty knives as shown. Photo: NPS files.

the interior stop and the parting bead, particularly along the seam where these stops meet the jamb. This can be accomplished by running a utility knife along the length of the seam, breaking the paint bond. It will then be much easier to remove the stop, the parting bead and the sash. The interior stop may be initially loosened from the sash side to avoid visible scarring of the wood and then gradually pried loose using a pair of putty knives, working up and down the stop in small increments. With the stop removed, the lower or interior sash may be withdrawn. The sash cords should be detached from the sides of the sash and their ends may be pinned with a nail or tied in a knot to prevent them from falling into the weight pocket.

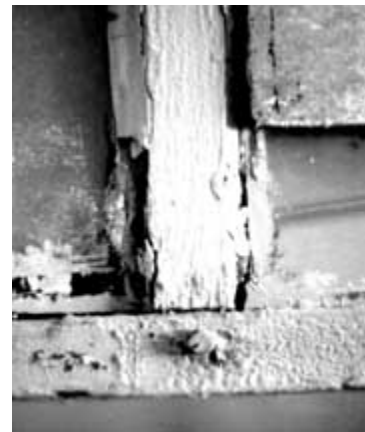
This historic double-hung window has many layers of paint, some cracked and missing putty, slight separation at the joints, broken sash cords, and one cracked pane. Photo: NPS files.

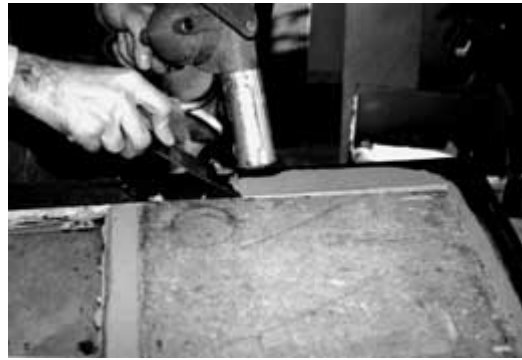
Sash can be removed and repaired in a convenient work area. Paint is being removed from this sash with a hot air gun. Photo: NPS files.

The sash can be stripped of paint using appropriate techniques, but if any heat treatment is used, the glass should be removed or protected from the sudden temperature change which can cause breakage. An overlay of aluminum foil on gypsum board or asbestos can protect the glass from such rapid temperature change. It is important to protect the glass because it may be historic and often adds character to the window. Deteriorated putty should be removed manually, taking care not to damage the wood along the rabbet. If the glass is to be removed, the glazing points which hold the glass in place can be extracted and the panes numbered and removed for cleaning and reuse in the same openings. With the glass panes out, the remaining putty can be removed and the sash can be sanded, patched, and primed with a preservative primer. Hardened putty in the rabbets may be softened by heating with a soldering iron at the point of removal. Putty remaining on the glass may be softened by soaking the panes in linseed oil, and then removed with less risk of breaking the glass. Before reinstalling the glass, a bead of glazing compound or linseed oil putty should be laid around the rabbet to cushion and seal the glass. Glazing compound should only be used on wood which has been brushed with linseed oil and primed with an oil based primer or paint. The pane is then pressed into place and the glazing points are pushed into the wood around the perimeter of the pane.

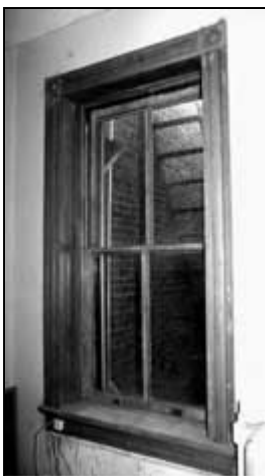
Following the relatively simple repairs, the window is weathertight, like new in appearance, and serviceable for many years to come. Photo: NPS files.

The operations just discussed summarize the efforts necessary to restore a window with minor deterioration to "like new" condition. The techniques can be applied by an unskilled person with minimal training and experience. To demonstrate the practicality of this approach, and photograph it, a Technical Preservation Services staff member repaired a wooden double-hung, two over two window which had been in service over ninety years. The wood was structurally sound but the window had one broken pane, many layers of paint, broken sash cords and inadequate, worn-out weatherstripping. The staff member found that the frame could be stripped of paint and the sash removed quite easily. Paint, putty and glass removal required about one hour for each sash, and the reglazing of both sash was accomplished in about one hour. Weatherstripping of the sash and frame, replacement of the sash cords and reinstallation of the sash, parting bead, and stop required an hour and a half. These times refer only to individual operations; the entire process took several days due to the drying and curing times for putty, primer, and paint, however, work on other window units could have been in progress during these lag times.

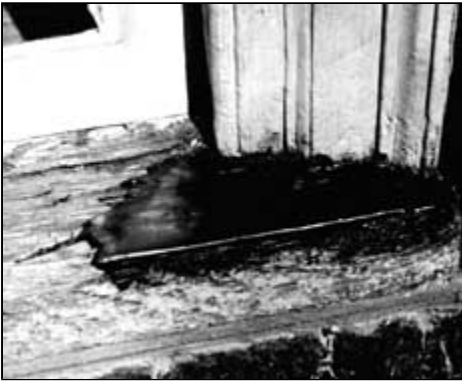
This illustrates a two-part epoxy patching compound used to fill the surface of a weathered sill and rebuild the missing edge. When the epoxy cures, it can be sanded smooth and painted to achieve a durable and waterproof repair. Photo: NPS files.

Wood may also be strengthened and stabilized by consolidation, using semirigid epoxies which saturate the porous decayed wood and then harden. The surface of the consolidated wood can then be filled with a semirigid epoxy patching compound, sanded and painted. Epoxy patching compounds can be used to build up missing sections or decayed ends of members. Profiles can be duplicated using hand molds, which are created by pressing a ball of patching compound over a sound section of the profile which has been rubbed with butcher's wax. This can be a very efficient technique where there are many typical repairs to be done. The process has been widely used and proven in marine applications; and proprietary products are available at hardware and marine supply stores. Although epoxy materials may be comparatively expensive, they hold the promise of being among the most durable and long lasting
