The Preservation of Historic Glazed Architectural Terra-Cotta

de Teel Patterson Tiller

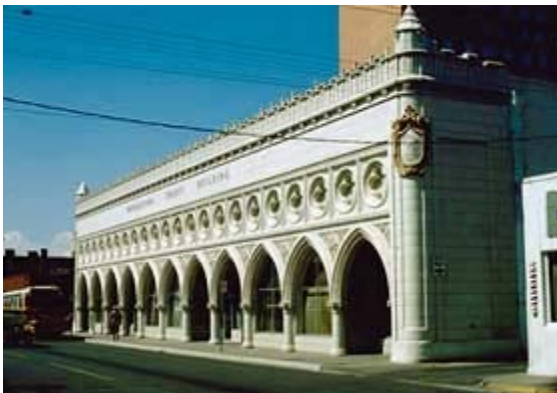
Glazed architectural terra-cotta was a practical and highly decorative building material. Photo: NPS files.

Glazed architectural terra-cotta was the most complex development of terra-cotta as a masonry building material in this country. The hollow units were hand cast in molds or carved in clay and heavily glazed (often in imitation of stone) and fired. Sometimes called "architectural ceramics," glazed architectural terra-cotta was developed and refined throughout the first third of the 20th century and has been closely associated with the architecture of Cass Gilbert, Louis Sullivan, and Daniel H. Burnham, among others. Significant examples in this country include the Woolworth Building (1913) in New York City and the Wrigley Building

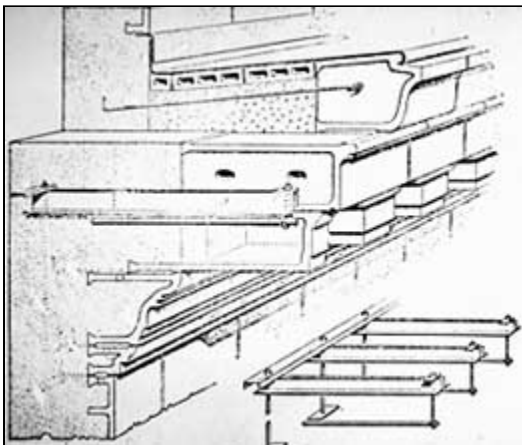
Typical construction detail of glazed architectural terra-cotta ornament. Drawing: Detail, Architectural Terra Cotta, Charles E. White, Jr., 1920.

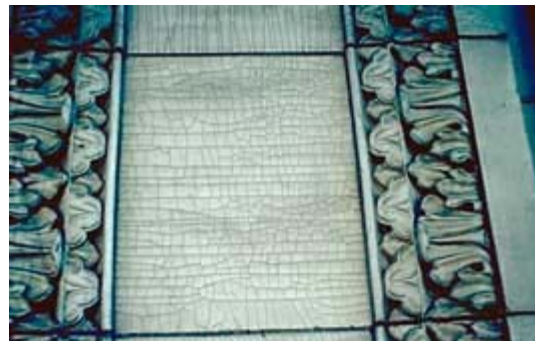
Water and air-borne moisture entering the glazed architectural terra-cotta causes expansion of the porous clay body, increasing its volume. This upsets the "fit" of the glaze and makes its surface shatter, which is commonly called "crazing." Photo: NPS files.

Crazing, or the formation of small random cracks in the glaze, is a common form of water-related deterioration in glazed architectural terra-cotta. When the new terra-cotta unit first comes from the kiln after firing, it has shrunk (dried) to its smallest possible size. With the passage of time, however, it expands as it absorbs moisture from the air, a process which may continue for many years. The glaze then goes into tension because it has a lesser capacity for expansion than the porous tile body; it no longer "fits" the expanding unit onto which it was originally fired. If the strength of the glaze is exceeded, it will crack (craze). Crazing is a process not unlike the random hairline cracking on the surface of an old oil painting. Both may occur as a normal process in the aging of the material. Unless the cracks visibly extend into the porous tile body beneath the glaze, crazing should not be regarded as highly serious material failure. It does, however, tend to increase the water absorption capability of the glazed architectural terra-cotta unit.

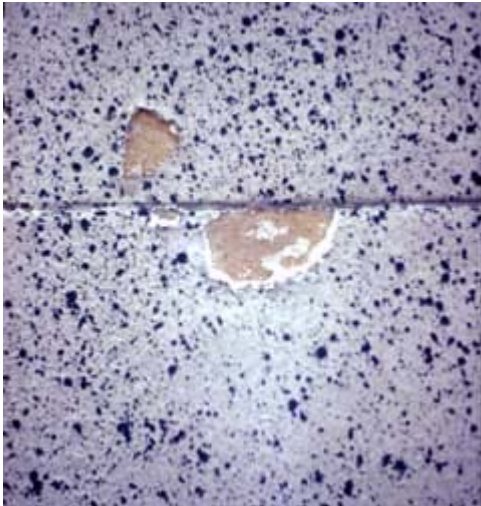
Blistering of the glaze, like crazing, is the result of the increase in water in the porous clay body and the subsequent destruction of the glaze as a result of water migration and pressure. Glaze spalling may also be caused by deterioration of metal anchors behind the terra-cotta unit. Photo: NPS files.

Glaze spalling (left) may appear as small coin-size blisters where the glaze has ruptured and exposed the porous tile body beneath. This may occur as several spots on the surface or, in more advanced cases of deterioration, it may result in the wholesale disappearance of the glaze. Spalling of the glaze may also be symptomatic of deterioration (rusting) of the internal metal anchoring system which holds the terra-cotta units together and to the larger building structure. The increase in volume of the metal created by rusting creates increased internal pressures in the terra-cotta unit which, in turn, may spall the glaze, or in more extreme cases, cause material spalling.

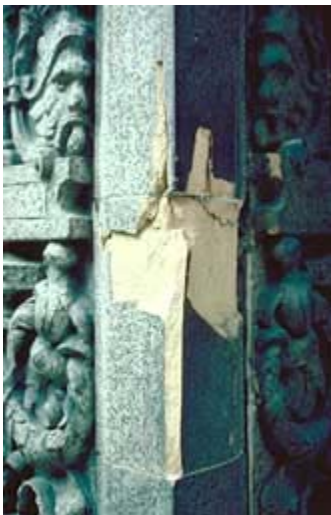
The damage shown here is the result of direct live load on a mid-rise building. The steel frame has settled and shifted the weight onto the exterior terra-cotta cladding, resulting in rupturing of the material. Photo: NPS files.

Stress-related deterioration: Stress-related deterioration of glazed architectural terra-cotta frequently occurs in high rise buildings. The evolution of stress relieving details (flexible joints, shelf angles, etc.) occurred late in the development of American building construction. Consequently, most early continuously clad High Rise buildings (c.1900-1920s) had little or no provisions for normal material and building movement in their original design.

The development of large stress-related cracks or wholesale material deterioration is often caused by unaccommodated building-frame shortening under load, thermal expansion and contraction of the facade and moisture expansion of the glazed architectural terra-cotta units themselves. Cracks running through many units or stories or large areas of material deterioration often indicate stress-related problems. This sort of deterioration, in turn, permits significant water entry into the terra-cotta system.

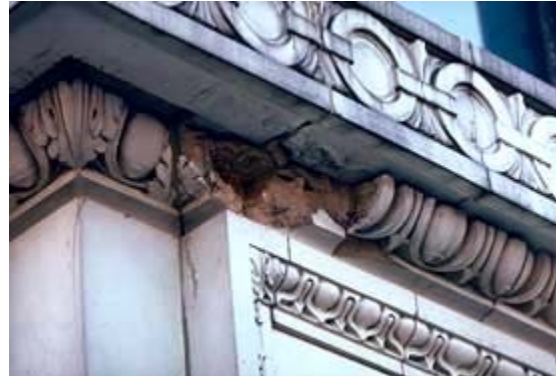
Material spalling is the result of excessive expansion of the porous tile body caused by water and freezing temperatures. This is a serious condition, often difficult to repair. Photo: NPS files.

Material spalling is a particularly severe situation. Not only is the visual integrity of the detailing impaired, but a large area of the porous underbody, webbing and metal anchoring is exposed to the destructive effects of further water entry and deterioration. Both glaze and material

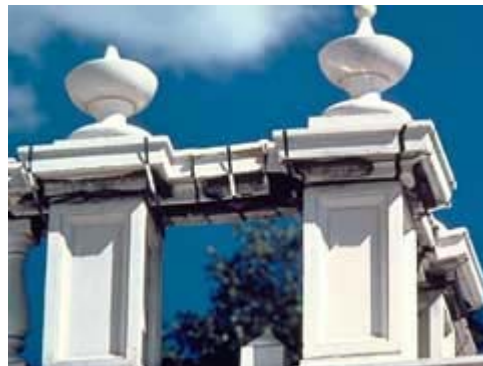
Exposed or freestanding terra-cotta detailing (parapets, urns, balusters, etc.) have traditionally been subjected to the most severe vicissitudes of deterioration as a result of freezing temperatures and water. Photo: NPS files.

spalling must be dealt with as soon as possible. Missing units is a serious situation which particularly plagues architectural terra-cotta systems. Unlike brick or stone, damaged glazed architectural terra-cotta is exceedingly difficult to replace. New production is extremely limited. Missing units create gaps which increase the structural load on the remaining pieces and also permit water to enter the system. Exposed or freestanding glazed architectural terra-cotta detailing (balusters, urns, parapet walls, etc.) are particularly susceptible to extensive loss of material.

These elements face the most severe vicissitudes of water and temperature-related deterioration in direct proportion to the extent of their exposure. The replacement of missing units should be a high priority work item in the rehabilitation of glazed architectural terra-cotta.

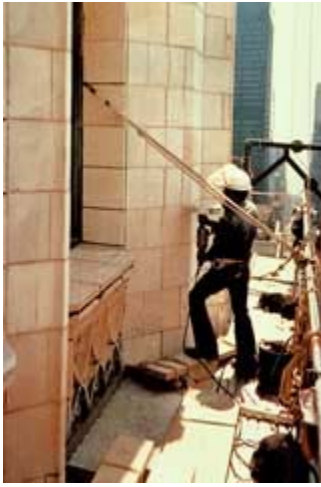
A worker cleans out mortar joints in preparation for repointing the architectural terra-cotta. Photo: NPS files.

Repointing: Repointing of mortar which is severely deteriorated or improperly or infrequently maintained is one of the most useful preservation activities that can be performed on historic glazed architectural terra-cotta buildings. Ongoing and cyclical repointing guarantees the long life of this material. Repointing should always be carried out with a mortar which has a compressive strength (measured in p.s.i.) *lower* than the adjacent masonry unit. Hard (Portland cement) or coarsely screened mortars may cause point loading and/or prevent the outward migration of the water through the mortar joints, both of which ultimately damage

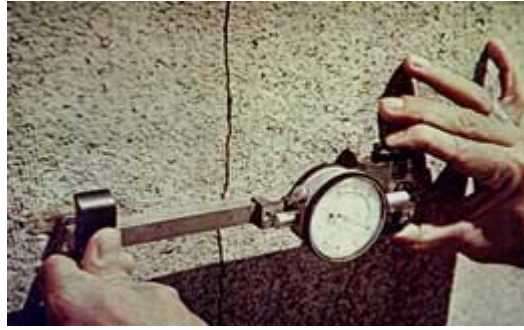
This crack is being measured. Structural cracking, whether static (nonmoving) or dynamic (moving) should be caulked to prevent water entry into the glazed architectural terra-cotta system. Photo: NPS files.

Repair of addition and structural damage: Holes, sign anchors, slots for channel steel, or structural cracking in the surface of glazed architectural terra-cotta

cladding should be permanently sealed with a material that will expand with the normal dynamics of the surrounding material, yet effectively keep water out of the system. Any one of a number of commercially available waterproof caulking compounds would be appropriate for this work. Holes and static (non-moving) cracks may be caulked with butyl sealants or acrylic latex caulks. For dynamic (moving or active) cracks, the polysulfide caulks are most often used, although others may be safely employed. It is, however, important to remember that these waterproof caulking compounds are not viable repointing materials and should not be used as such.
