Repairing Historic Flat Plaster Walls and Ceilings

Mary Lee MacDonald

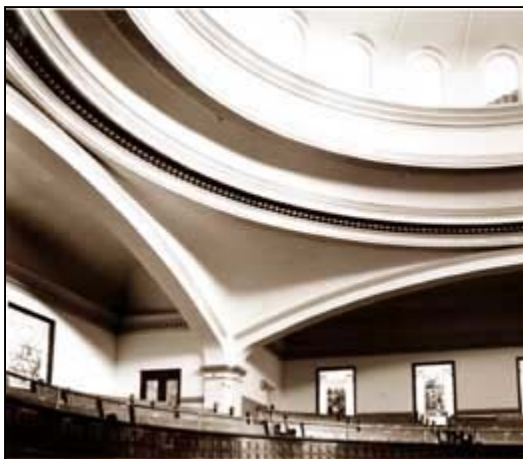
Plaster was used as the interior surface coating of this elegant 1911 church located in Eugene, Oregon. Photo: NPS files.

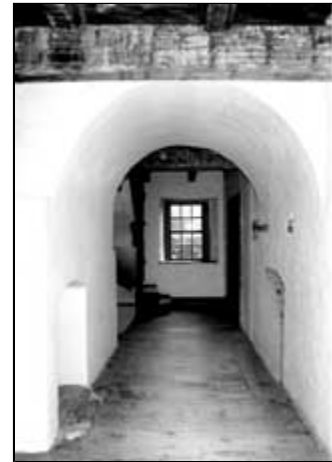
Schifferstadt, a simple house of German origin that dates to 1756, utilized plaster for both flat and curved walls. The building is located in Frederick, Maryland Photo: NPS files.

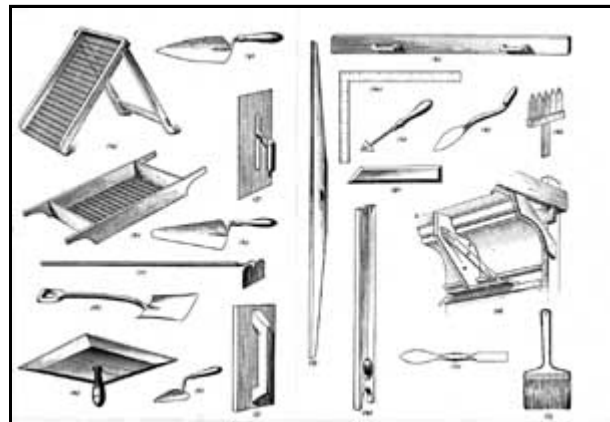
Many of these traditional plastering tools are still used today. Drawing: NPS files.

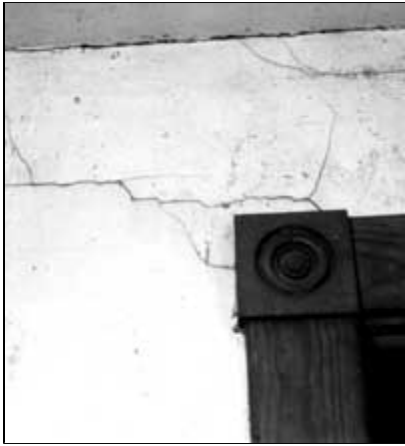
Stress cracks in plaster over a kitchen door frame can be repaired using fiberglass mesh tape and joint compound. Photo: NPS files.

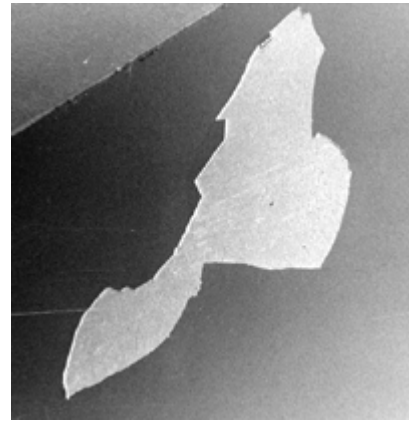
The smooth-trowled lime finish has delaminated from the brown coat underneath. Photo: Marylee MacDonald.

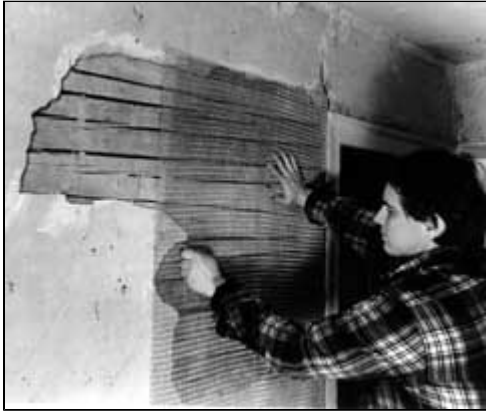
In this New Hampshire residence dating from the 1790s, the original plaster was a single coat of lime, sand, and horsehair applied over split lath. A one-coat repair, in this case, is appropriate. Photo: John Leeke.

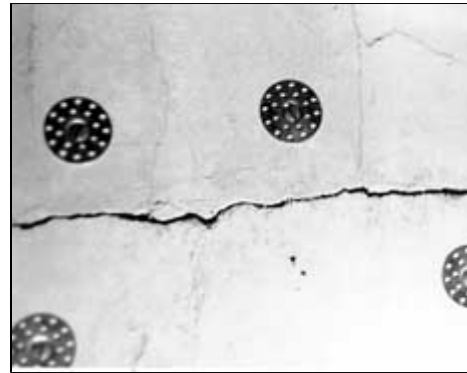
Flat-head wood screws and plaster washers were used to reattach loose ceiling plaster to the wood lath. After the crack is covered with fiberglass mesh tape, all will be skim-coated with a patching compound. Photo: John Obed Curtis.

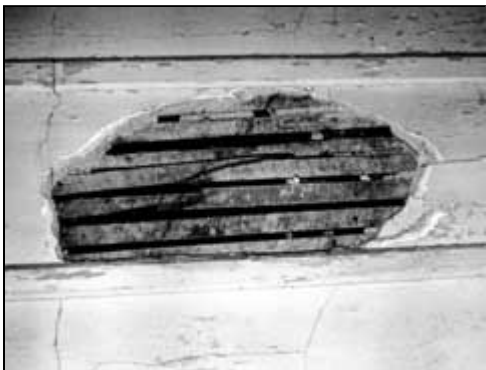
This beaded ceiling in one of the bedrooms of the 1847 Lockwood House, Harpers Ferry, West Virginia, is missing portions of plaster due to broken keys. Photo: NPS files.

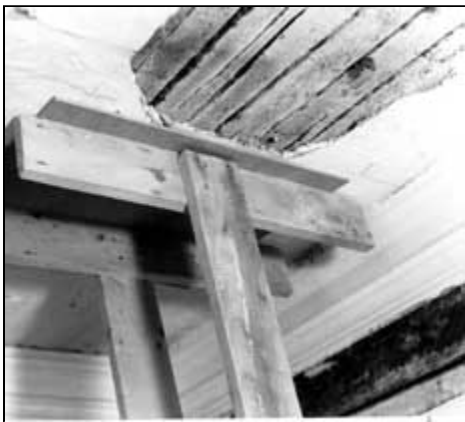
When ceiling repairs are made with wet plaster or with an injected adhesive mixture, the old loose plaster must be supported with a plywood brace until re-keying is complete. Photo: John Leeke.
